FAILURE INVESTIGATION FOR INPUT SHAFT OF AUXILIARY HOIST GEAR BOX.

Rahul S Korde and Amol N Patil.

This review paper gives the insights of various analysis & tests carried out to find shaft failure type & its causes. Failed shaft is used in auxiliary hoist gear box for torque transmission. Shaft failed with fewer cycles of operations in very early stage of life span. The various literatures has been systematically studied, compared and reviewed to get a proper shaft failure analysis and their causes. Every analysis method has its advantages and disadvantages and used by specific industrial areas. Shaft failure causes the unnecessary shutdowns and leads to larger production losses. The objective of this paper is to study various shafts failure analysis techniques and select the best method to find out the root cause for failure of shaft used in crane hoist.

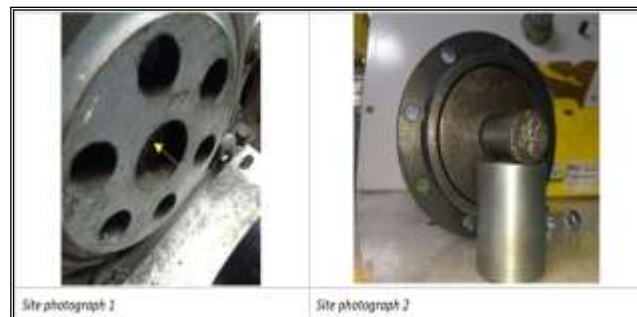
In this study, we have analysed input shaft of auxiliary hoist gear box which failed in the form of fracture after a year of operation. Material of shaft is as per DIN EN 10084 Grade 20MnCr5. As informed the shaft is in hardened and tempered condition. The teeth portion of the shaft is case carburized. The failure of shaft was seen during hoisting operation at the customer site and it was not going in upward direction. The crane was being operated in no load condition. So the maintenance team checked the gear box and it was found that the shaft had failed. The failure was seen at 50% production load. For this specific crane, the failure was noticed for first the time. The site photograph and drawing showing failed shaft are as given below:

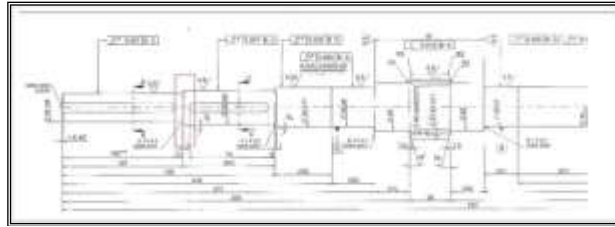
Failed area of shaft has been marked red in below drawing

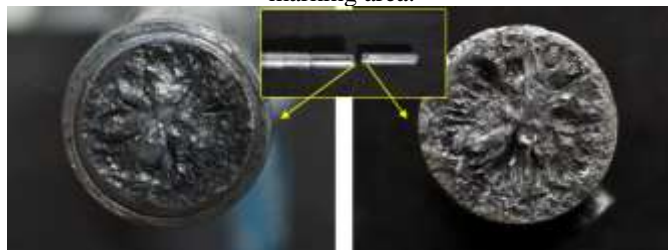
Plate: 1 Shows broken piece of input shaft of hoist gear box in as-received condition. The fracture region is in the marking area.

Plate: 2 Shows fracture surface view. Despite some rubbing marks on fracture surface star shaped pattern is visible.

Plate: 3 Shows fracture surface view of the smaller part of shaft. Here also, star shaped pattern is visible with no deformation on the contours.

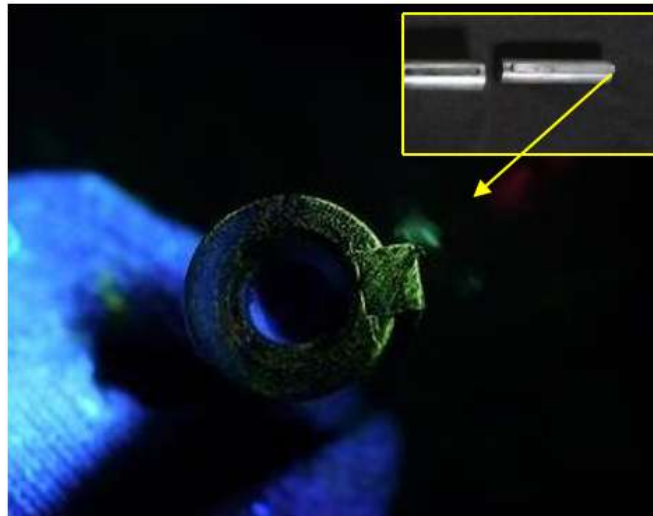
Plate: 4 The small surface plan view in WFMPI tested condition showing end opposite to the fracture surface. A linear indication seen at key way area

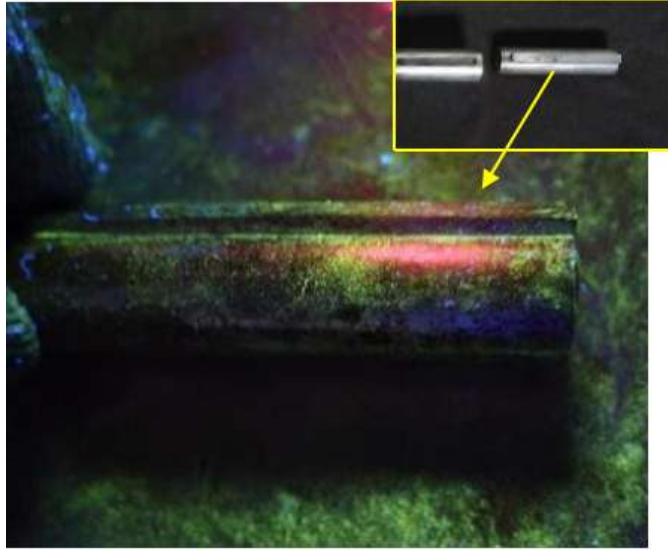
Plate: 5 Small shaft outer surface view surrounding the key way location. A tiny hairline crack like indication is seen on the surface.

5. Dimensional measurement does not indicate any abnormal variation or distortion on the shaft. No deformation is seen on the key way contours.
6. WFMPi highlights randomly oriented hairline cracks on shaft surface at location even away from the fracture.

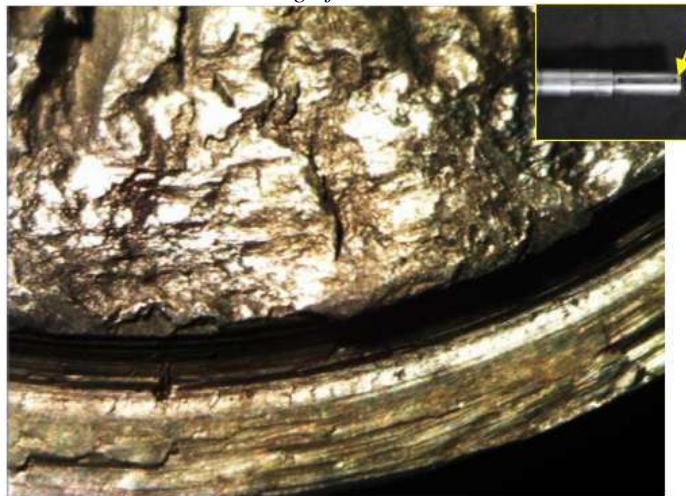
Plate: 7 Shows fracture surface low magnification view at the edges. The multiple ratchet marks are seen. Auxiliary cracking is also noticed. The rubbing is observed that seems to be post failure (10X)

7. Low magnification view highlights multiple ratchet marks on the fracture contours along with secondary cracks. This is followed by star shaped patterns accentuating torsion fatigue mode of failure.

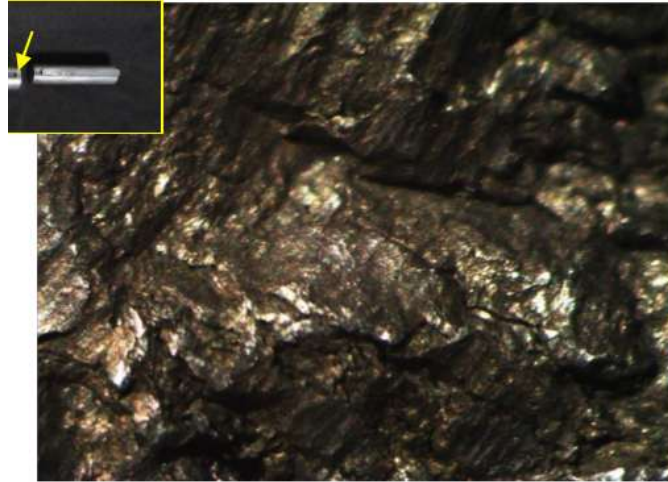
Plate: 8 Shows fracture surface low magnification view in the central portion. Petals of star pattern indicating torsional fatigue mode of failure are seen (20X)

The fracture surface indicates star shape pattern with multiple facets in smooth petal like shape oriented in radial direction indicating failure under torsional fatigue.

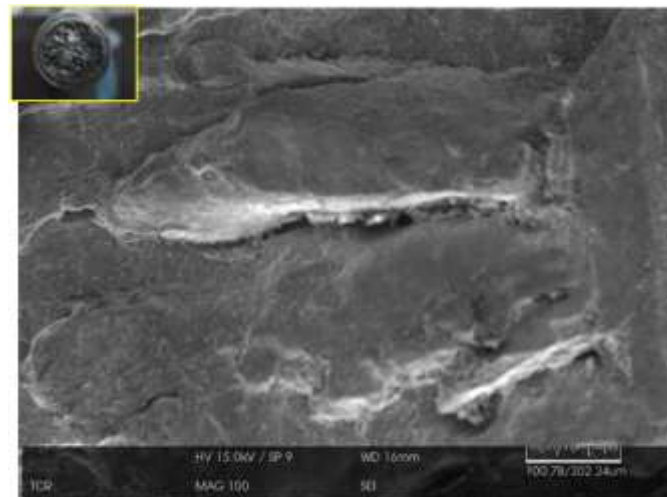
Plate: 9 Shows fracture surface view where petal like grooves indicative of starry fracture characteristic of torsional fatigue are seen. (100X)

8. MOC of the shaft conforms to EN 10084 grade 20MnCr5.
9. SEM highlights petals formed on the edges of the fracture surface indicative of starry fracture characteristic of torsional fatigue mode of failure.

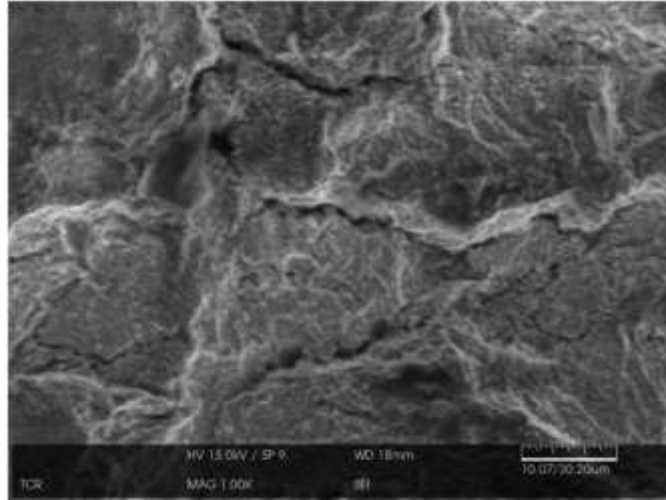
Plate: 10 Shows core portion of fracture surface view with secondary cracks. (1000X)

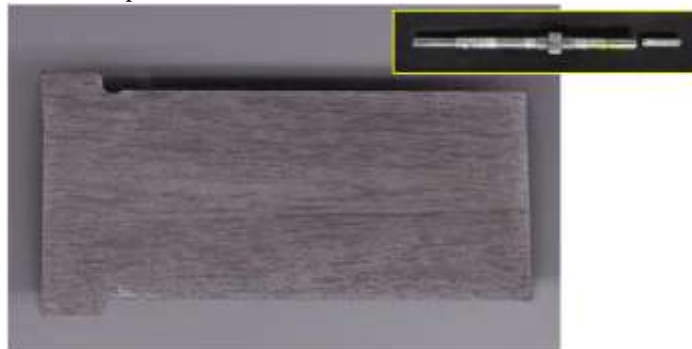
Plate: 11 Shows sample in macro etched condition. Normal grain flow is visible and it is free from any internal defects.

10. Macrostructural examination indicates normal grain flow and the shaft is free from any internal defects.
11. Microstructural examination highlights following:

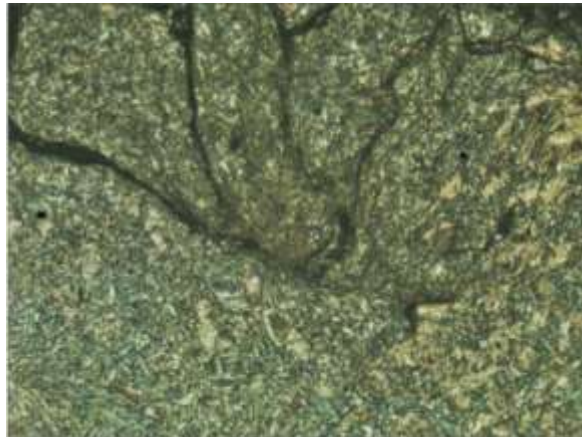
Plate: 12 Shows fracture edge microstructure of tempered martensite. Grains are slightly deformed at the edges. Crack network with uneven contours caused due to deformation is seen (200X)

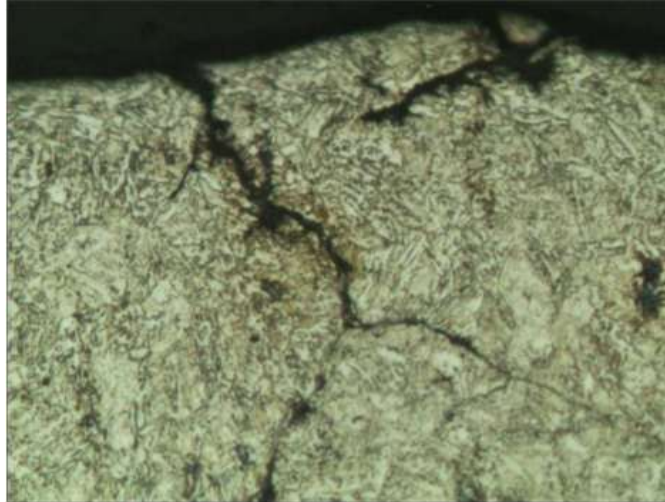
Plate: 13 Shows fracture edge microstructure of tempered martensite with ferrite traces. Transgranular cracking with fine tips and non-uniform contours are seen. (400X)

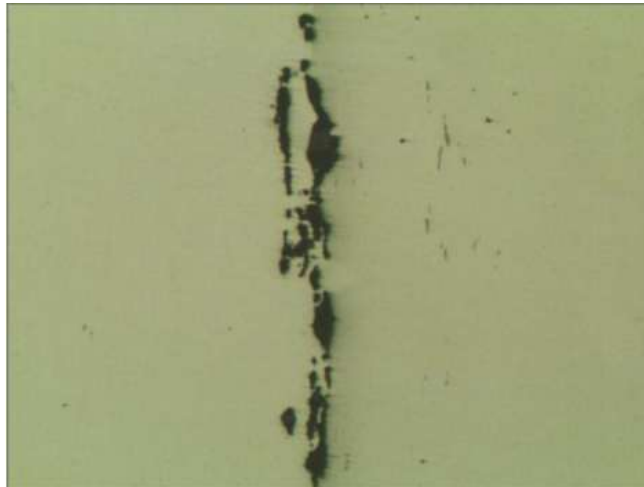
Plate: 14 As-polished view showing internal discontinuity which appears to be scale entrapment. (100X)

MOC, microstructure and hardness values appear to be normal. However, the metallurgical integrity of the shaft is inferior in terms of poor tensile strength and increased level of inclusions in cluster form in localized regions. Moreover, centerline discontinuity in the form of scale entrapment is also noticed, although it has not influenced the damage scenario.

The shaft quality needs to be improved from metallurgy point of view in terms of reduced inclusions and freedom from center line discontinuity.

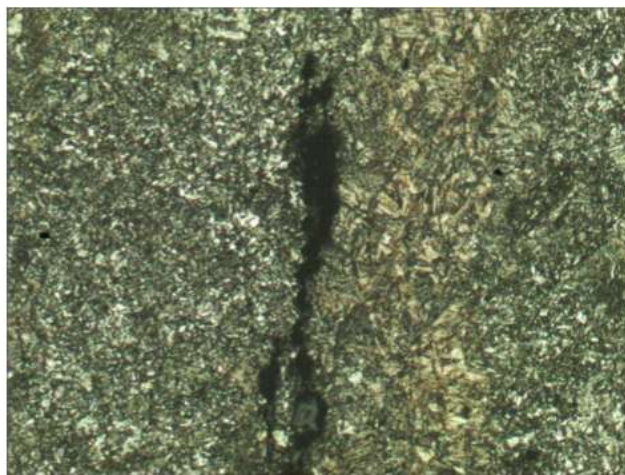
Plate: 15 Shows scale entrapment assuming the shape of crack with non uniform contours. Microstructure is tempered martensite with traces of ferrite. (200X)

12. Close cluster of inclusions that are elongated in shaft matrix. Oxide scale entrapment.
13. Scale entrapment at the edges assuming the shape of the crack.

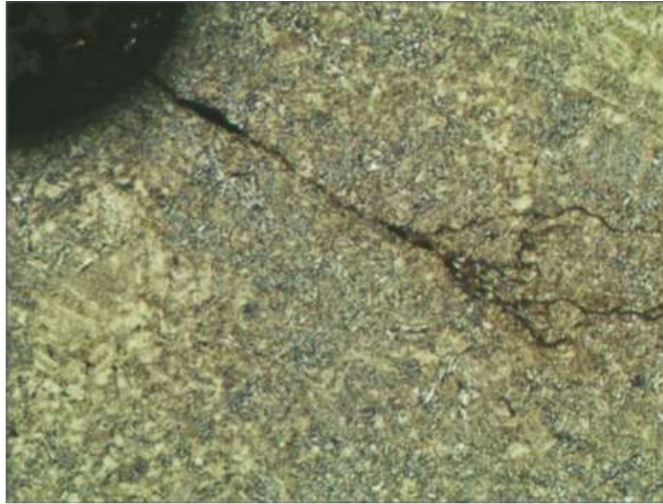
Plate: 16 Shows crack initiating from the keyway contour that has become branching in nature as it propagates. Microstructure is ferrite in traces and tempered martensite. (100X)

15. Fracture surface indicates cluster inclusions and cracks having random contours. The grains at fracture edge are deformed with cracks.
16. Transgranular fatigue mode of cracking is seen initiating from the key way contours. That is away from the failure region.
17. Rubbing marks are seen on the outer surface along with uneven external metal surface layer.
18. Microstructure tempered martensite with traces of ferrite.
19. Tensile test results show lower 0.2% PS and UTS values.
20. Impact test results at room temperature indicate good toughness of the material.
21. Hardness values appear to be normal.

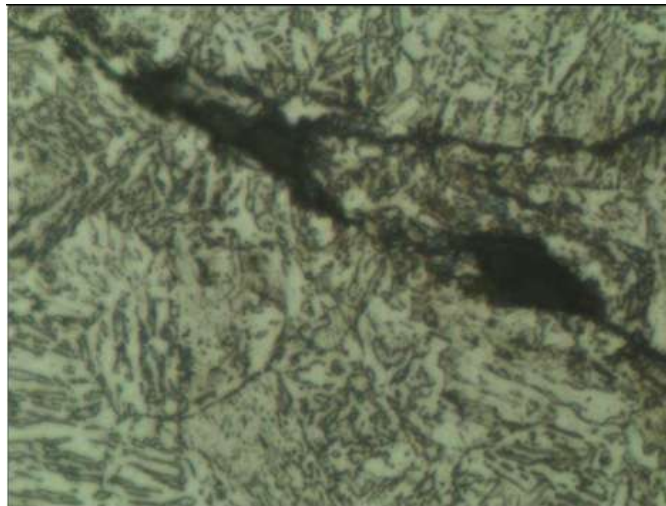
Plate: 17 Shows high magnification view at crack tip with branching tendency. Microstructure is ferrite traces and tempered martensite. (1000X)
