INTERNATIONAL JOURNAL
OF ADVANCED RESEARCH

EMPIRICAL APPROACH IN GEOTECHNICAL ANALYSIS OF FAILURES OF CUTSLOPES: A CASE STUDY

R K Das^{1*} and A Dasgupta²

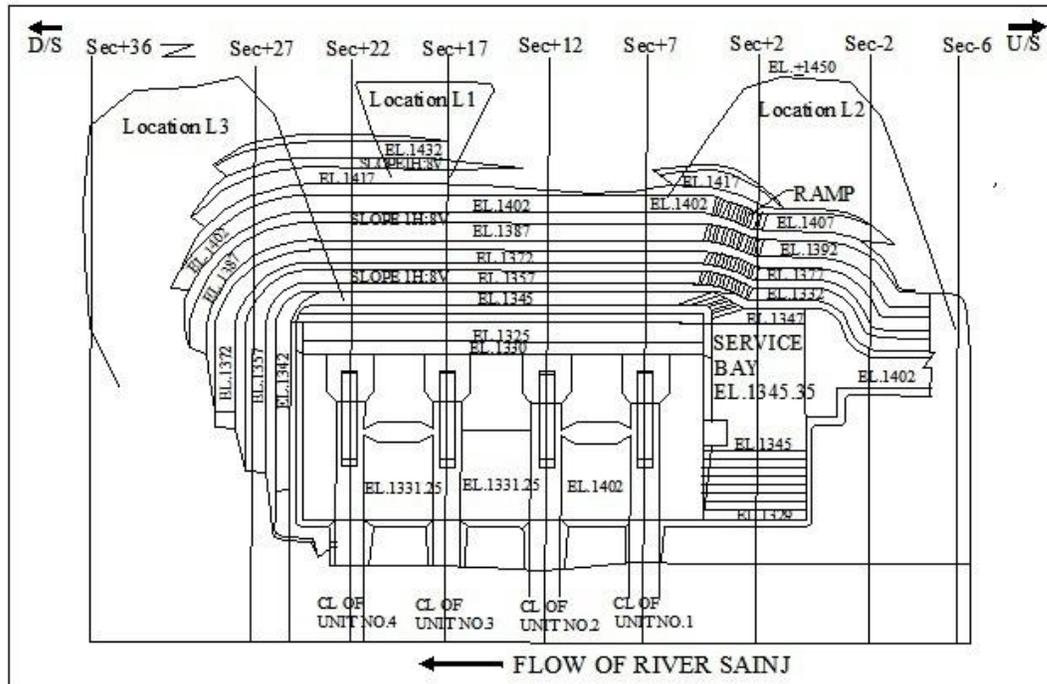
Fig.2 Powerhouse Excavation Plan and Sketch showing Location of Failures L1, L2 and L3

The excavation plan of the powerhouse cut slopes (Fig.2) shows the highest and lowest level is 1432M and 1331M respectively. From upstream to downstream, the entire cutslope was divided in Sections (-) 6 to (+) 36 each separated by 5m. These Sections are represented as -6, -5,..... to -1, 0, +1, +2,.....+36 . The portion between Section +8 and Section +24 is straight and in downstream portion between Sections +24 to Section +36, the cut faces are in curved portion.

The (Third slide, Fig.5) of the powerhouse slope took place in the downstream portion of cutslope. This slide extended up to EL ± 1495 m above unit 3 and 4. The slided muck along with rock chunks with rock anchors covered upto unit 2 portion. The estimated amount of slided muck was 30000-32000 cum. Shotcrete at various berms was also got detached. Rock swelling above berm EL ± 1346 m was also observed. More than 75% of the already treated portion falls down between sections +18 to +32. (Bhatnagar and Das, 2013). In totality, wedge failure and three slides took place. For analysis, wedge failure named as Location L1, First slide as Location L2 and Second and Third Slide as Location L3 respectively (Fig.2).

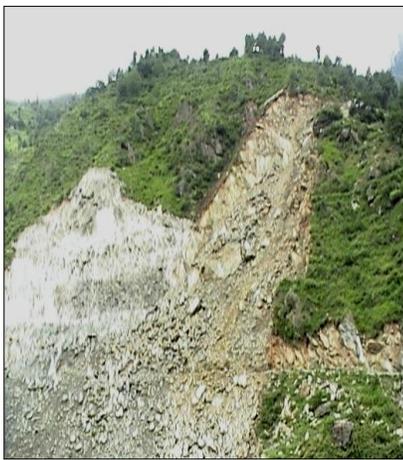
Fig.3 First Slide

Later, the development of 1-50mm wide cracks in the Power House Cut slope was observed. These cracks proved fatal and a slide (1st slide, Fig.3) took place in the service bay area between section +9 to -7 starting from El ± 1440 to ± 1368 M. This slide later extended upto El ± 1480 M. It appears that all the features i.e. wedge failure, valley dipping joints which are vulnerable due to their orientation viz-a viz the cut slope and heavy precipitation culminated to form slip circle failure and caused major slide in the service bay area.

The Stereographic projection of the discontinuities using Dips and the plane failure model was developed using S- Wedge (Fig.8), shows that there would be planar failure along the foliation plane $110^{\circ}/75^{\circ}$. The wedge failure is not likely to occur. The calculated FS using limiting equilibrium method is 0.527 under maximum cohesive strength of 305KPa but it was not likely the case as the cohesion between two joints was much less than 100 KPa due to soil filling between the joints and the FS calculated is 0.290 and tabulated using Eqn. (1) Table 11.

Keeping in view of three slides which took place at various section and elevations, the rock support for stabilizing the cutslope was modified as follows:

- (i) Rock slope at different berms was reconsidered and more land above EL $\pm 1495\text{M}$ was acquired for maintaining proper slope. The excavation of the backslope started from EL $\pm 1510\text{M}$. A cross drain of 1m width x 0.5m height was constructed at EL 1520M to drain out the surface runoff. The slope was cut down to the level of $\pm 1330\text{M}$. Between EL 1492M to 1402m a 1H: 2.5V slope was maintained whereas between EL 1372M to 1330M the slope was kept as 1H: 3.5V. Thus a vertical slope of about 200m height with intermediate benches at approx 15m interval was to be stabilized, which was a challenging task.

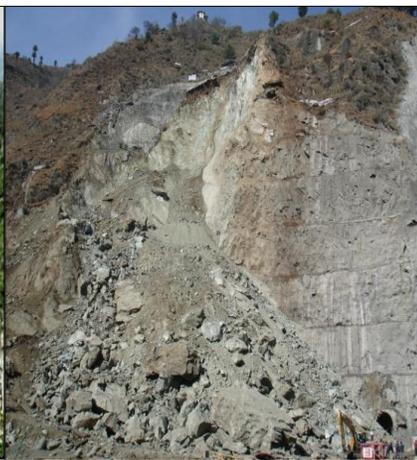
Fig.4 Second Slide

Again a major jump in the instruments readings and increase in width of the cracks (2cm -10cm) was noticed. After this incident, all the blasting and other activities were suspended in this portion and the excavation work was taken from the upstream side. When the excavation work reached near the desired level in the unit-3 & 4, the cracks started showing widening and the instrumentation reading shot up to alarming values. Subsequently the area of cut

slopes in the d/s of Section +18 from El ± 1372 (apparently) to Section +36 at El 1440-1450m started sliding. The estimated amount of slided muck was around 30,000 to 35,000 m³ (Second slide, Fig.4).

The Stereographic projection of the discontinuities using Dips and the plane failure model was developed using S- Wedge (Fig.9) shows that there would be planar failure along the foliation plane $067^{\circ}/50^{\circ}$. The wedge failure is not likely to occur. The calculated FS using limiting equilibrium method is 1.419 under maximum cohesive strength of 305KPa but as the cohesive strength decrease due to opening of joints and at 160KPa the block is just supported by the resistive force with FS as 1.00. If the cohesion between the foliation planes gets reduced to further, the block fails naturally. The FS has been calculated using Eqn. (1) is given in Table 12.

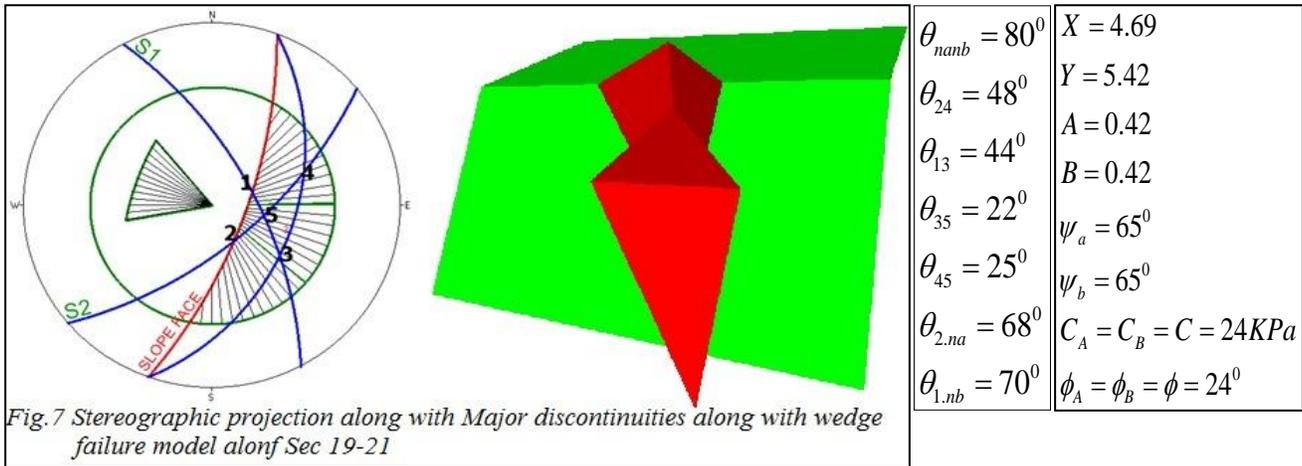
The Stereographic projection of the discontinuities using Dips shows formation of wedge that is dipping out of the slope face (Fig.7). The line of intersection formed by S1 and S2 is daylight on slope face on which the formed wedge had been slide down. The wedge failure model was developed using S- Wedge. The values of θ 's are obtained from the stereoplot (Fig.7) (Hoek and Bray (1981), Anbalagan et al (2007). The FS calculated is tabulated using Eqn.(2) Table10.

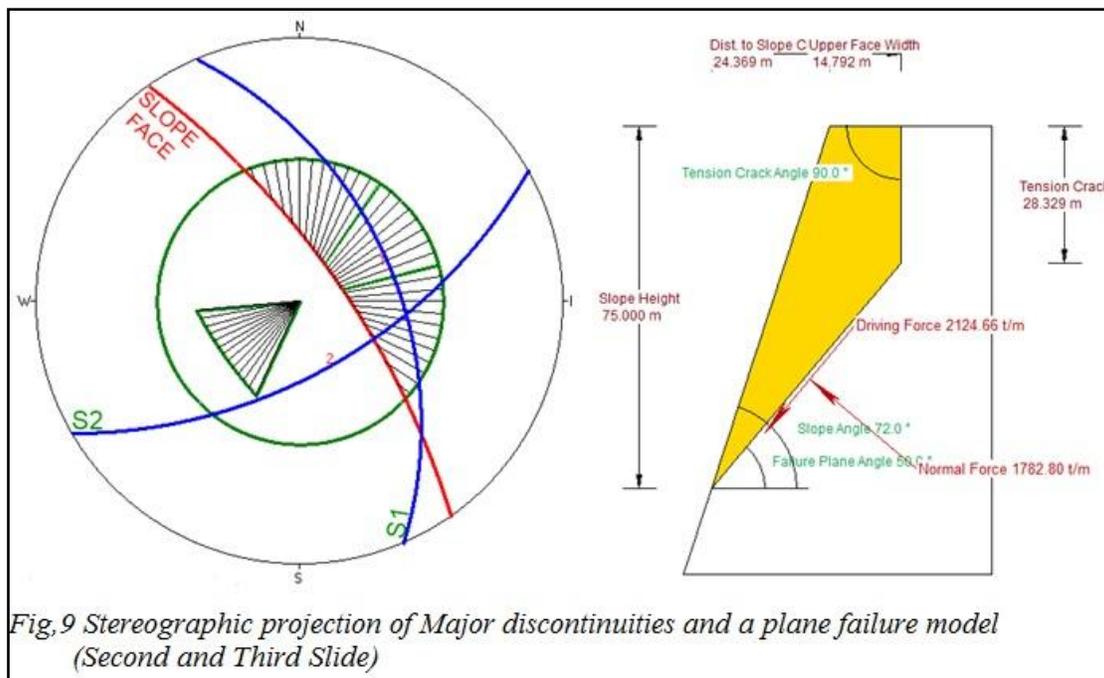
S1: $067^{\circ}/50^{\circ}$, S2: $150^{\circ}/60^{\circ}$, Slope face: $110^{\circ}/70^{\circ}$, Intersection $S1 \wedge S2$: $104^{\circ}/58^{\circ}$

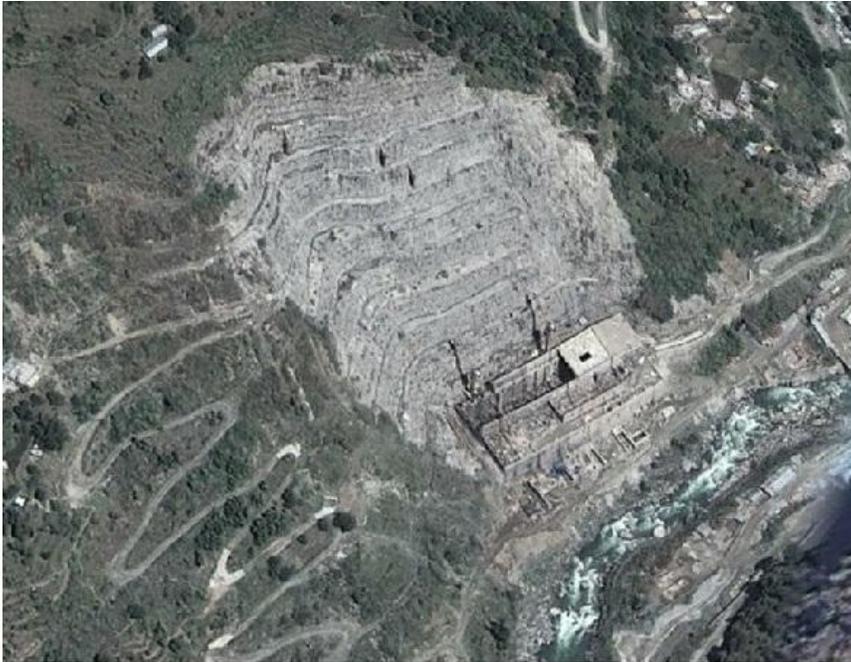
Fig.10 Google earth image of Stable treated cut slope & construction of surface powerhouse in progress.

(viii) Fig. 10 shows Google earth image of Stable treated powerhouse cut slope after failure and construction of surface powerhouse is in progress
