#### STUDY ON THE RISK OF COLLAPSE OF BLOCK WALLS IN JAPAN DURING EARTHQUAKES

**Kensuke Goto<sup>1</sup>, Takehiro Goto<sup>2</sup> and Keinosuke Gotoh<sup>3</sup>**

Risk of Collapse, Block Wall,  
Earthquake

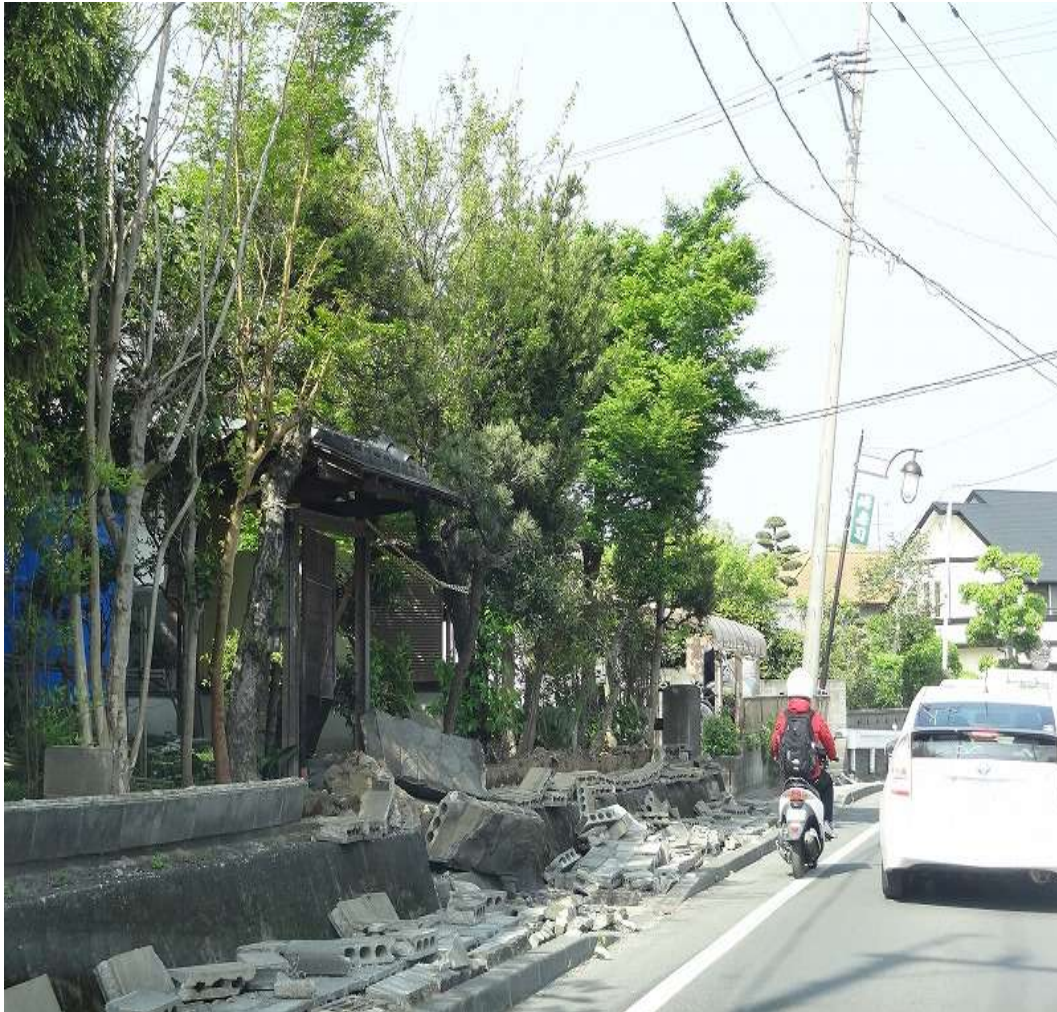
In terms of human damage, there were 272 fatalities (50 confirmed in police autopsies, whereas remaining were earthquake-related deaths), and 2737 injuries of various degrees. There was also massive residential damage, including 8657 completely destroyed houses, 34,491 partially destroyed, and 155,143 partially damaged (all including earthquake-related damage). In this earthquake, the extent of residential damage was remarkable. As of July 12, 2016, around three months after the earthquake, Mashiki Town (where two tremors with a seismic intensity of 7 were observed) had 2665 completely destroyed houses, accounting for about 30% of all residential damage in the town, whereas houses suffering partial destruction or more accounted for more than half of all the residential damage. Older houses, in particular, were noteworthy for the collapse of block walls, in addition to many houses that were completely collapsed (Fig 1). A man in his twenties was crushed to death after being buried under a collapsed block wall.

In the 2016 Kumamoto Earthquake as well, many sidewalks were obscured by collapsed block walls (Fig 1), and many houses had almost all their block walls collapsed. In most cases, these block walls were not reinforced or had suffered corrosion (Fig 2).

**Fig 1:-** Collapsed block wall on the sidewalk.

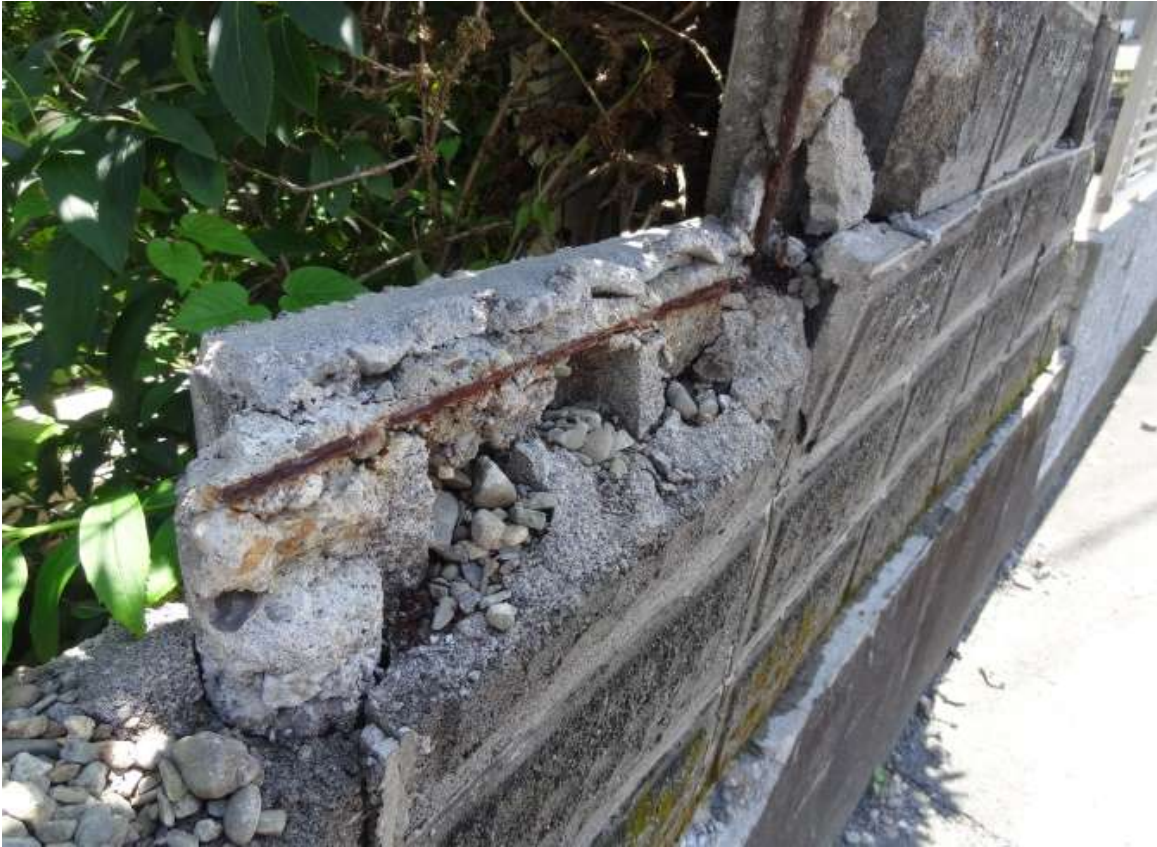
**Fig 2:-** Collapsed block wall with corroded rebars.

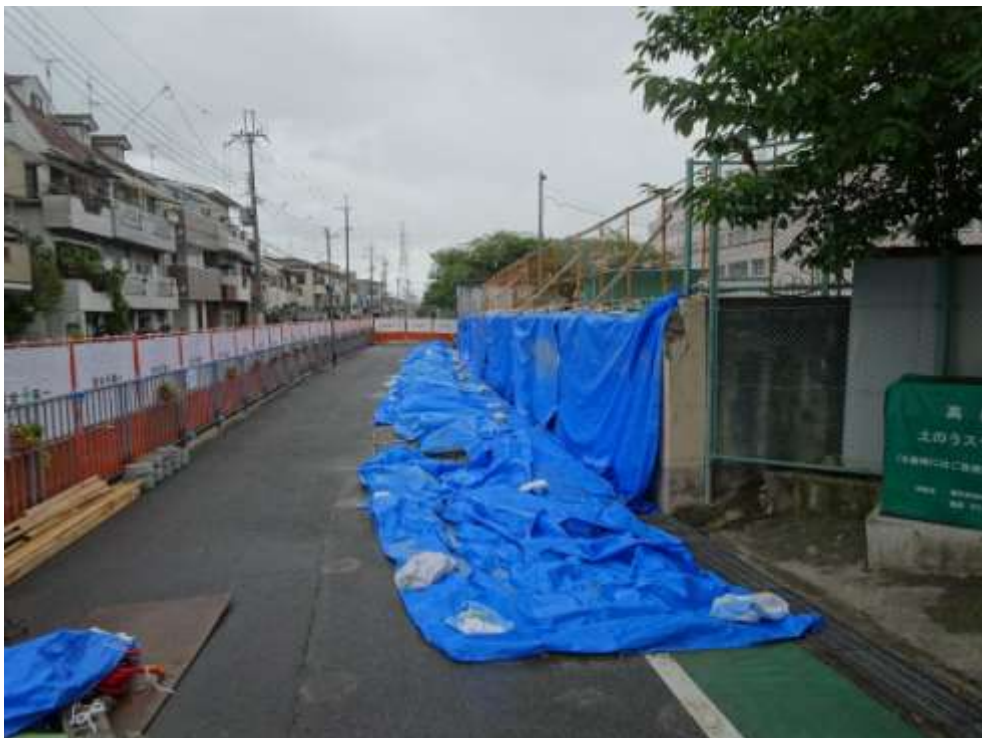
**Fig3:-** The collapsed elementary school block wall in the 2018 Osaka Earthquake.

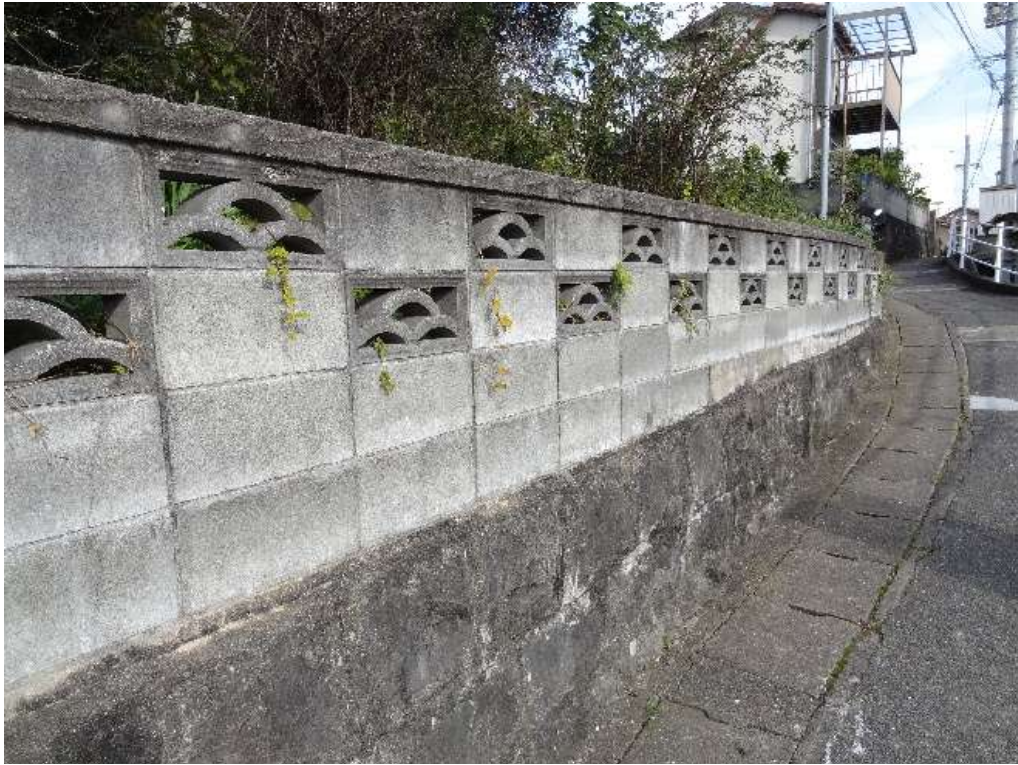
Fig 4:- Openwork block wall.

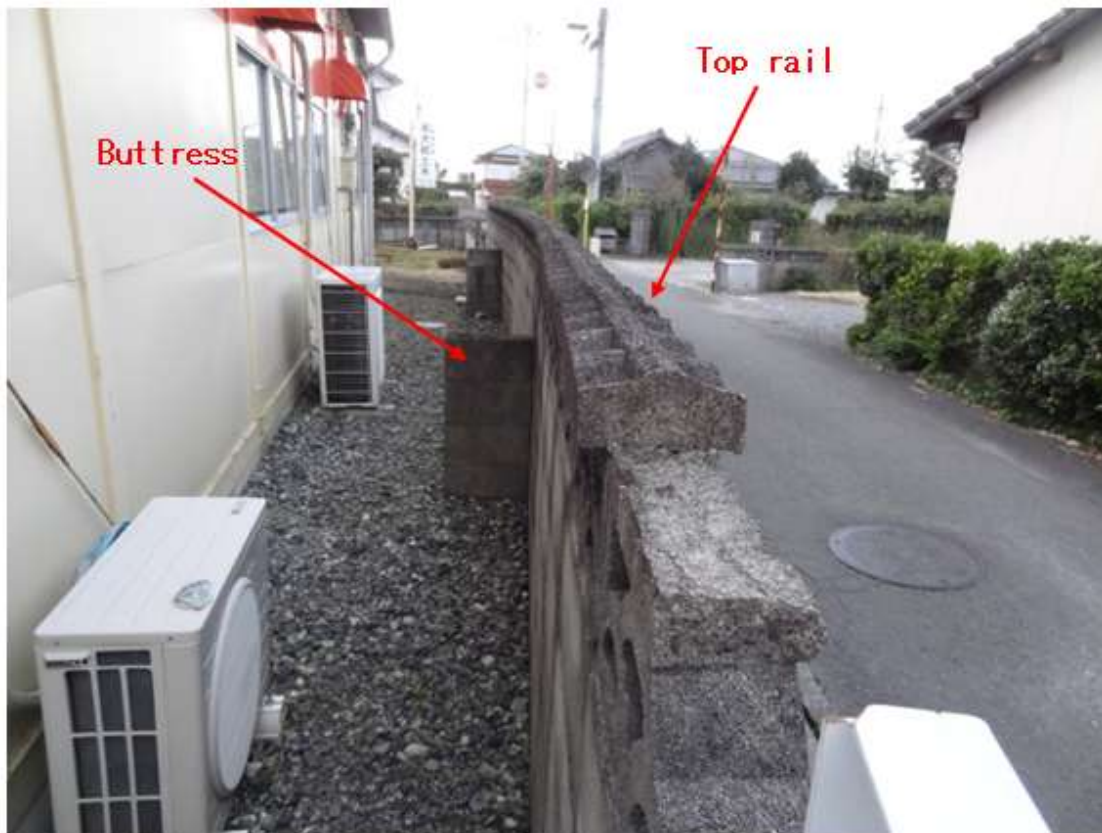
Fig 5:- Block wall with buttress and top rail.

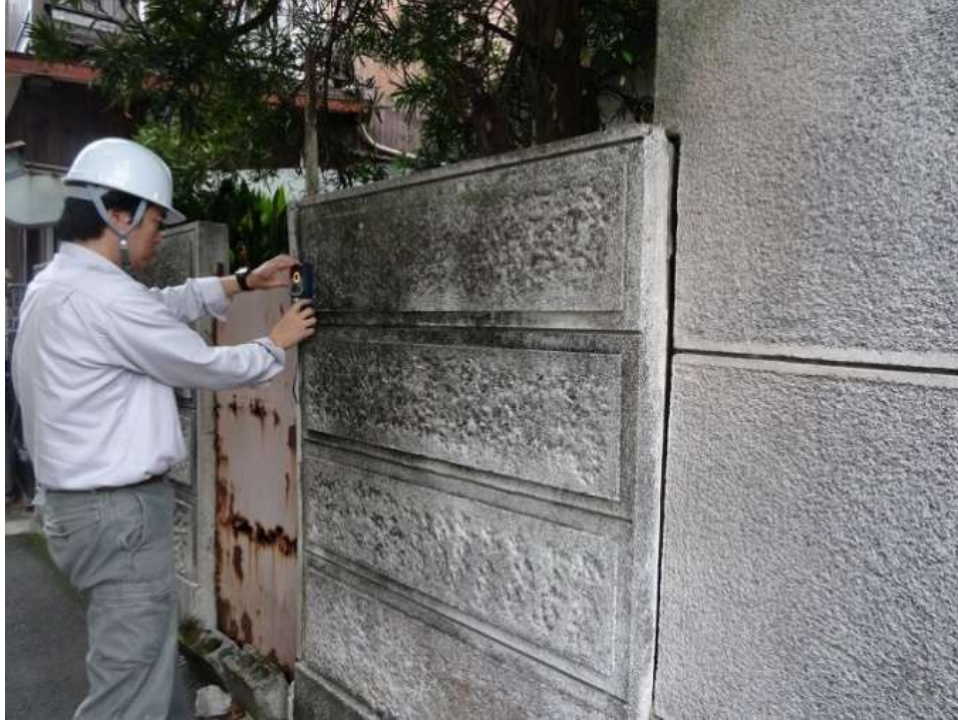
**Fig 6:-** Investigation of presence or absence of rebars using sensors.

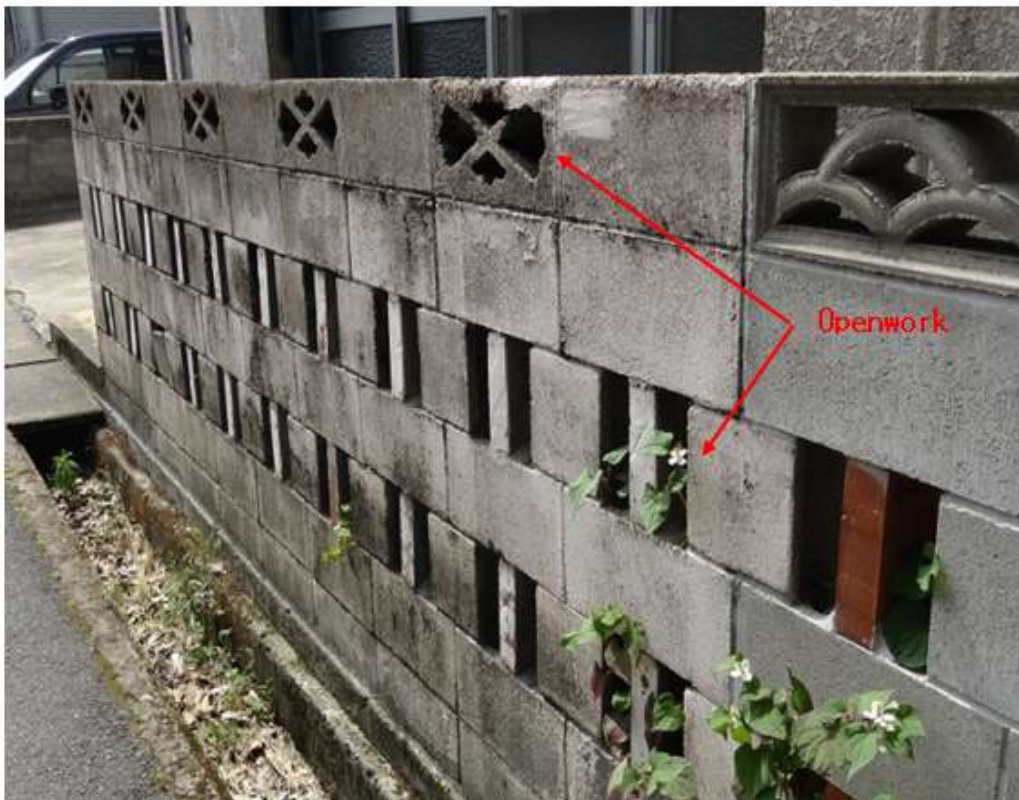
In the Kyushu area, 38% of block walls were dangerous or required caution. As a result of the chi-squared test and Fisher's exact test, it was observed that the lack of rebar ( $p < 0.01$ ), the presence of openwork ( $p < 0.01$ ) (Fig 7), and the age of the wall (20 years or more) ( $p < 0.01$ ) have a significant impact on danger or caution concerning block walls. On the contrary, in the Kanto area, 19% of block walls were dangerous or required caution. As a result of the chi-squared test and Fisher's exact test, it was found that lack of rebar ( $p < 0.01$ ), and lack of top rail ( $p < 0.01$ ) have a significant impact on danger or caution concerning block walls.

**Fig7:-** Block wall with openwork.

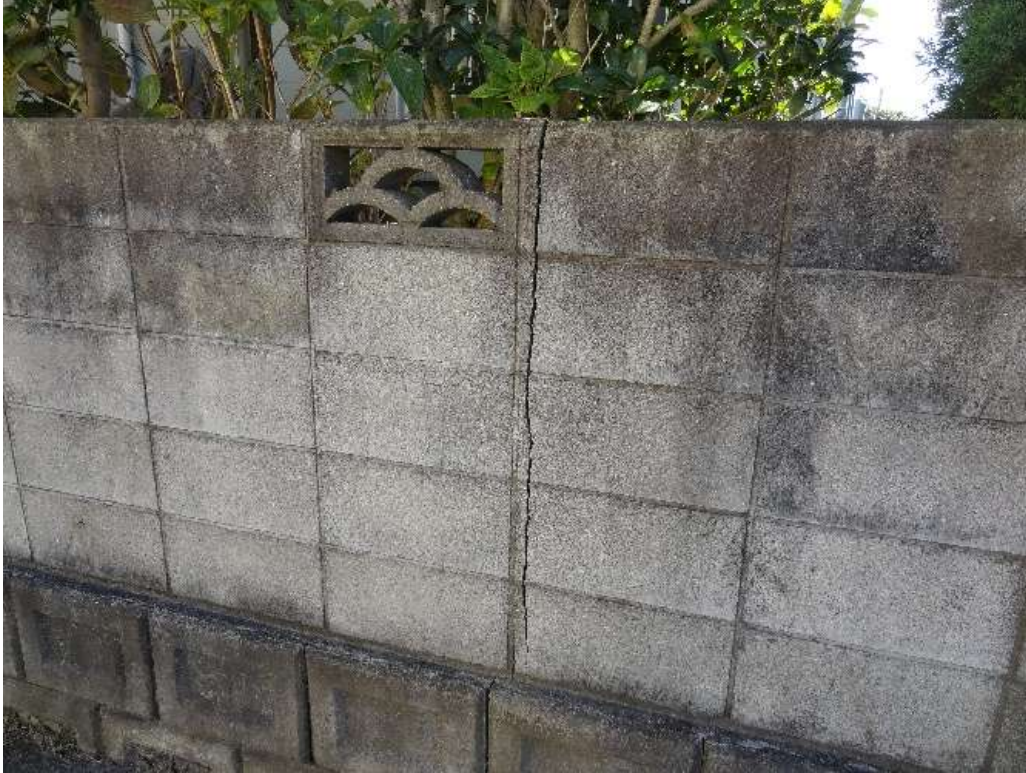
Majority of the owners in this survey were unaware of the fact that the block walls were not reinforced. It was found that the block walls were in state of collapsing due to poor workmanship by the contractors. In the Kumamoto Earthquake, where many block walls collapsed, it is thought that most of the residential block walls that fell either had no rebar or had become corroded. Considering this, surveys are urgently required with regard to the presence of rebar in particular. Moreover, there were many block walls that will undergo greater deterioration in the future, including those with major cracks, etc. (Fig 8).

**Fig 8:-** Block wall with major cracks.

Block walls have a durable life of about 20 to 30 years (Ravikumar et al., 2014; Kabeyasawa, 2017). However, as rebar corrodes due to the neutrality of the block as it deteriorates, block walls must be repaired or reinforced for houses which are 20 years old. Therefore, it is important to conduct diagnostic surveys of block walls such as those conducted in this study.

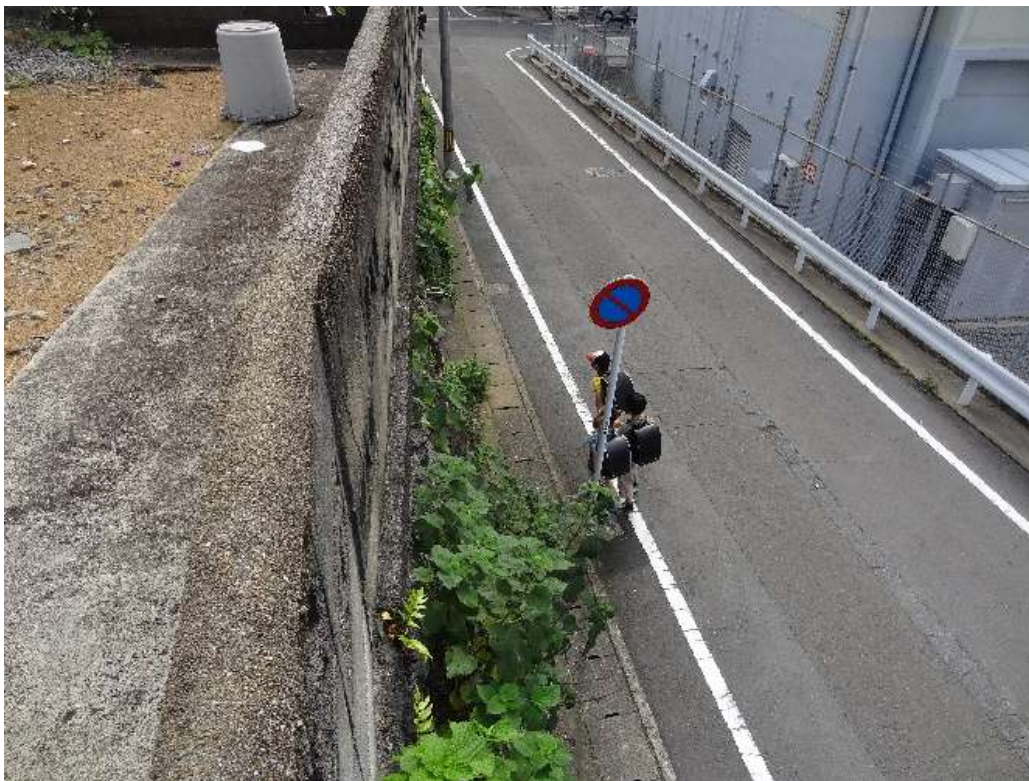
Currently, Japan is facing an issue of an increased rate of vacant houses; land and home ownership are often unclear. Therefore, even if block walls are diagnosed as being at a high risk of collapse as a result of a survey on block wall collapse risk, it is often difficult to take countermeasures. Likewise, our survey found that there were cases at sites with unknown owners where diagnosis revealed a high risk of collapse due to lack of rebar, etc. While it is difficult to take measures if the owner is unknown, there were cases in which children walk alongside those block walls as the land is located along a school route (Fig 9).

**Fig 9:-** Elementary school children passing beneath block walls diagnosed as high-risk for collapse and with unknown owners.
