RESEARCH ARTICLE

CONTRIBUTION OF RADAR INSPECTIONS TO THE IDENTIFICATION OF THE STATE OF CIVIL ENGINEERING WORKS.

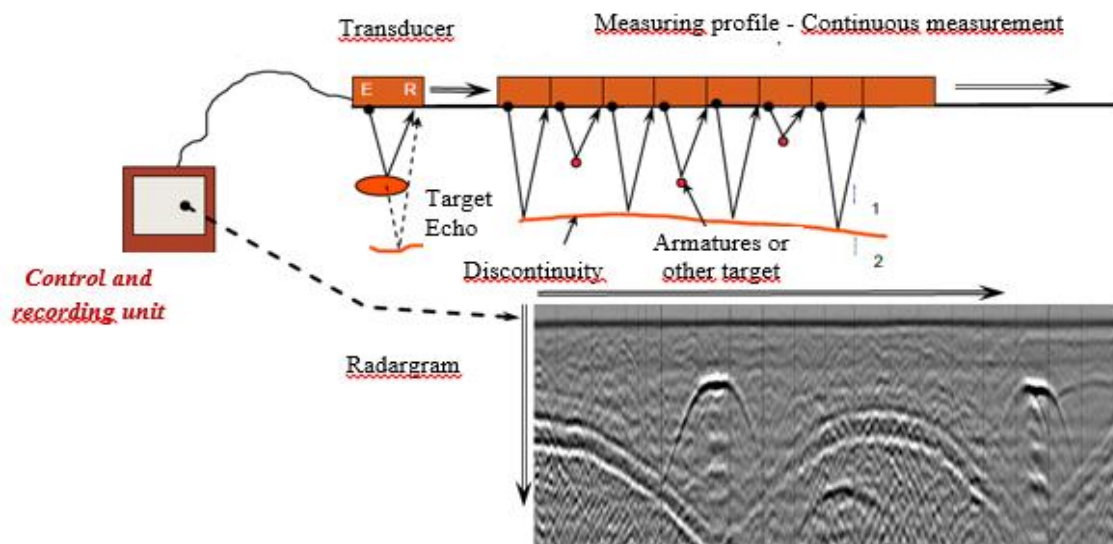
Radar-based diagnosis technique is based on the propagation of electromagnetic pulses of very short duration, emitted by a transmitter and an antenna specifically adapted for a non-air environment (Fig. 01). These pulses are partly reflected towards the surface by an interface between two materials that have different electromagnetic characteristics (relative dielectric permittivity ϵ_r). The unreflected part continues its way to the next interface, where a second echo occurs, and so successively on each interface. Successive echoes are received by a receiving antenna generally located near the transmitting antenna. The receiver therefore measures the amplitude of the electric field as a function of time. This measurement, for a fixed position of the antennas, corresponds to a "scan" [Garciaz, 2009]. Objects of spherical or cylindrical shape are represented on the radargram by diffraction hyperbolas.

Figure 01:-Principle of radar investigation and radargram recording

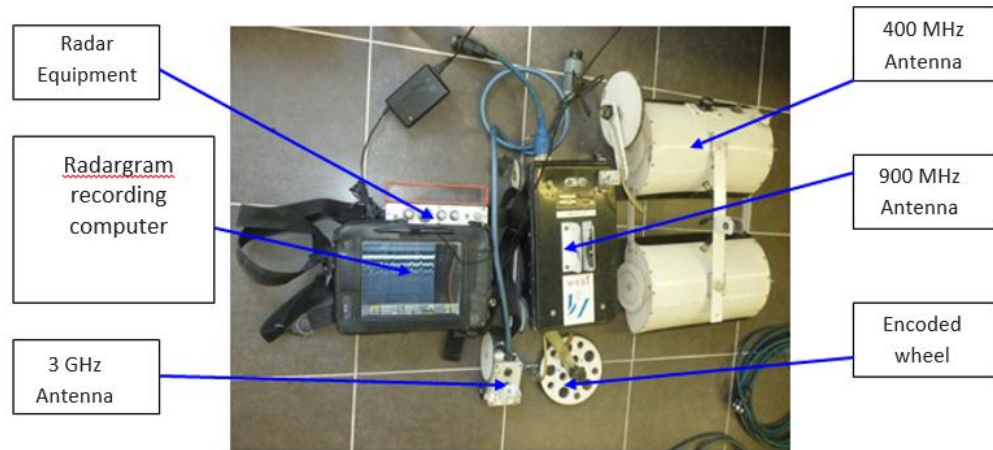
The acquisition equipment that has been used consists of a radar, a computer for recording real-time measurements and an encoder connected to the antenna. The "encoder - antenna" system is connected to the radar via a connector. Several antennas of varying frequencies were used: higher frequencies for shallower investigations, and lower frequencies for deeper investigations (Fig. 02).

Figure 02 :-Equipement radar et différentes antennes

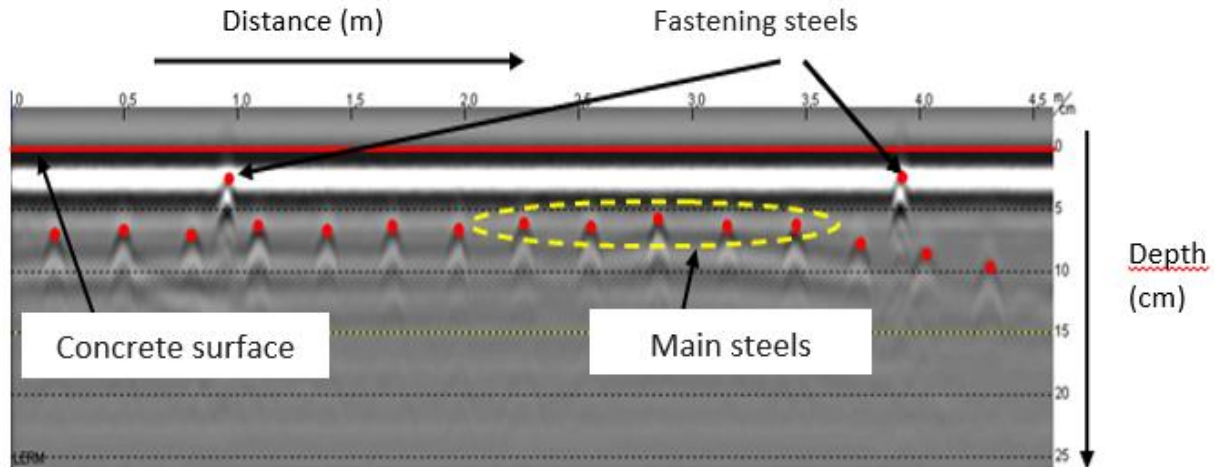
An example of a radargram, recorded on the support of a building bay is shown in Figure 3 (the irons are indicated in red).

Figure 02:-Radargram corresponding to the support of the bay

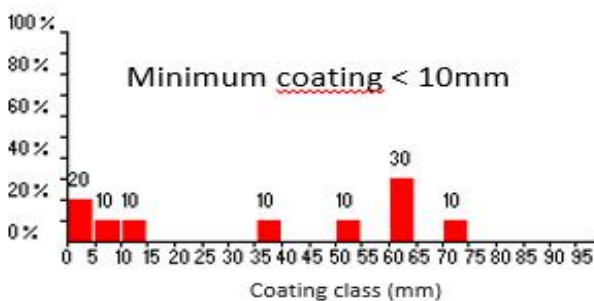
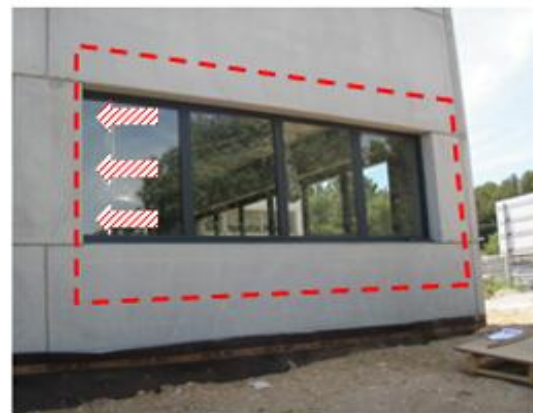
A statistic distribution diagram of the coatings is made for each type of surface examined (soffit, bay supports, bay amount ...). A distinction has also been made between vertical steels and horizontal steels (Table 01). Finally, on each diagram is recorded the minimum coating measured.

Figure 03:-Statistical distribution of reinforcement coatings in depth increments

On the diagrams of the bay, only the vertical and horizontal (interior) reinforcing bars have a coating greater than or equal to the required value. Therefore, these parts of the work have a coating sufficient to protect steels against aggressive agents. The other parts are strongly undercoated or slightly undercoated and the amount indicated by hatching in the photo (Fig. 04) has a coating less than 10mm.

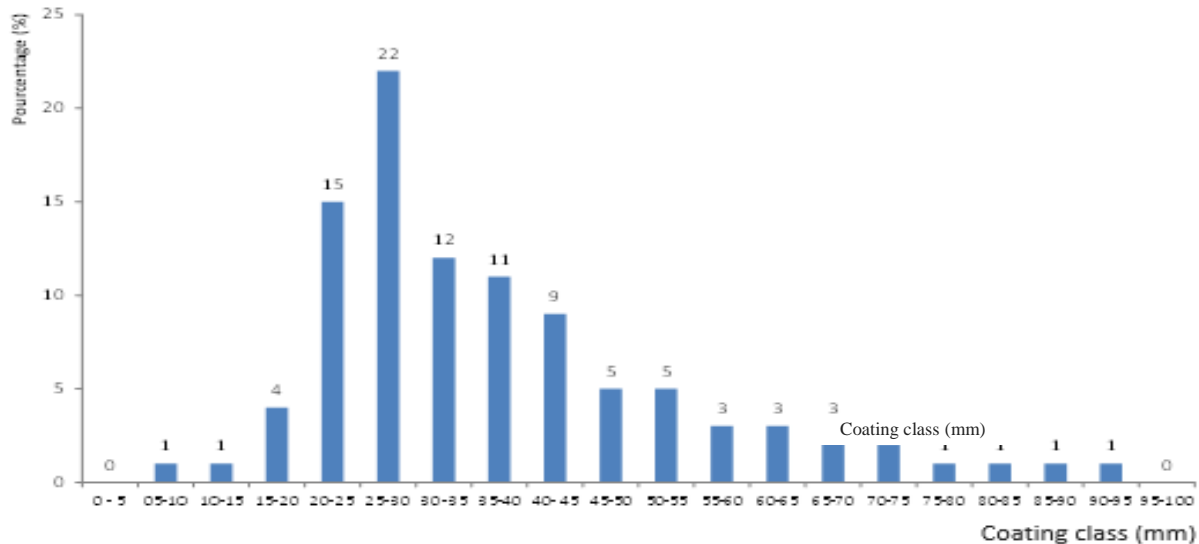
In order to obtain an overall view of the coating of steels, the diagram (Fig. 05) shows the statistical distribution of the coatings calculated on the entire building. It appears in total that:

1. 2% of the steels, whose coating is less than 15 mm, are strongly undercoated,
2. 19% of the steels, whose coating is between 15 and 25 mm, present a risk of corrosion with regard to the theoretical coatings required.

Figure 04:-General diagram of coating statistics

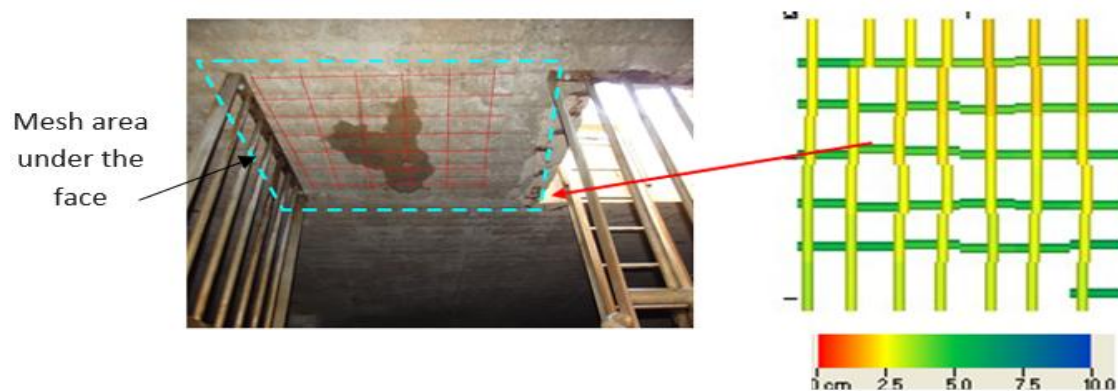
This study is carried out on a water tank. After defining an area of 2 m², vertical and horizontal profiles were made with the radar. A horizontal sampling of 150 scans / meter is chosen together with a listening time of 5 nanoseconds and a dielectric constant of 9.5 after calibration. The concrete is wet. After data processing, a reinforcement mapping is performed and coupled to a coating statistic. The distribution of rebars in concrete is shown in Figure 6.

Figure 05:-Coating mapping

Referring to the color palette, the mapping highlights that vertical frames are slightly under coated. Their coating oscillates between 25 and 50 mm, while the horizontal frames are well coated, between 50 and 75 mm. This study was conducted in order to establish a diagnosis. As a result, the following key points to the level of the face of the slab of the tank cover have been identified: the minimum coating of steels is 15 mm (92% of the frames in the fringe (0-30 mm)).

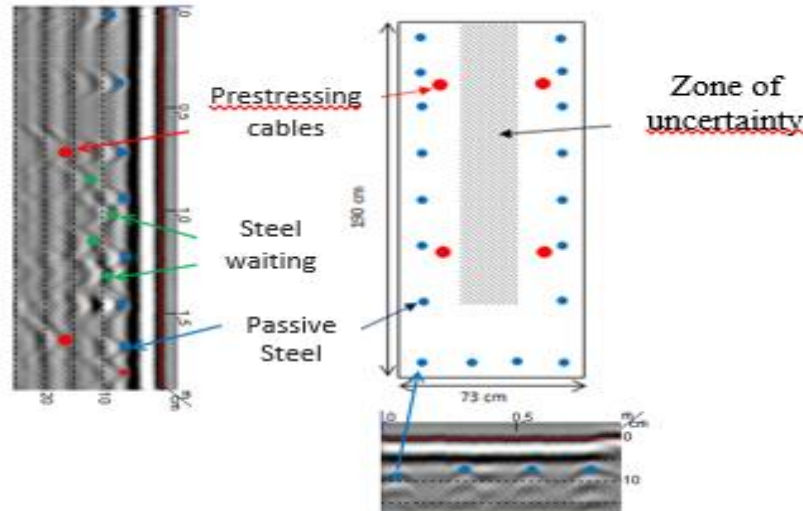
During the investigations, passive steels (in blue) and prestressing sheaths (in red) are identified. The spacer is bordered by two beams, the waiting steels (in green) connecting them are also detected. A difficult detection zone, given the density of irons and the thickness of concrete, is located in the center of the spacer. A representation in the form of a cross section (Fig. 07) and a longitudinal section (Fig. 08) are given.

Figure 06:-Transverse view showing steels position

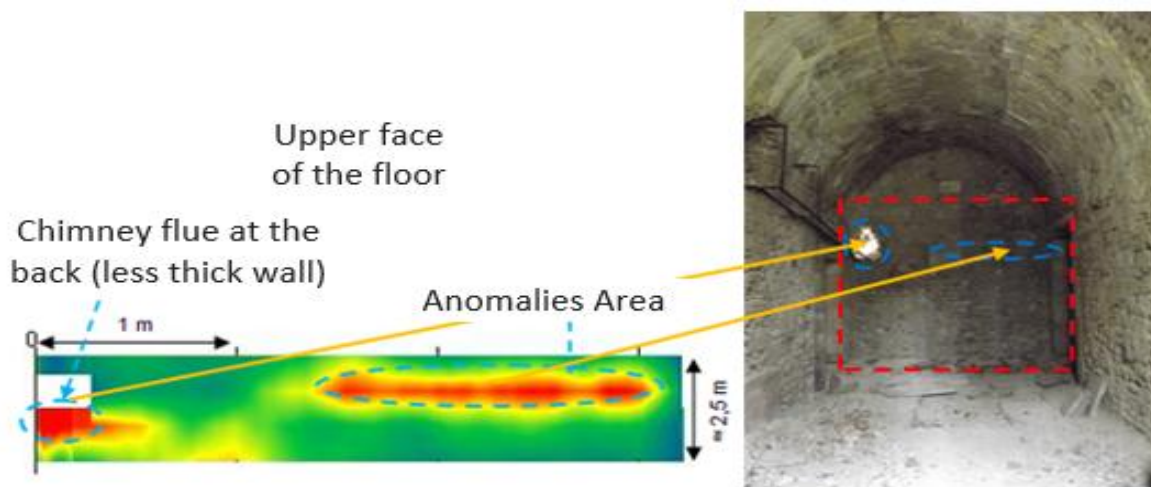
The wall has a hole where the thickness is the thinnest (anomaly on the left). The zone of anomalies corresponds to a decompressed masonry work or containing small voids distributed in a heterogeneous way. The rest of the wall is homogeneous, a sign of good internal cohesion of the masonry.

Figure 9:-Cartography and photography

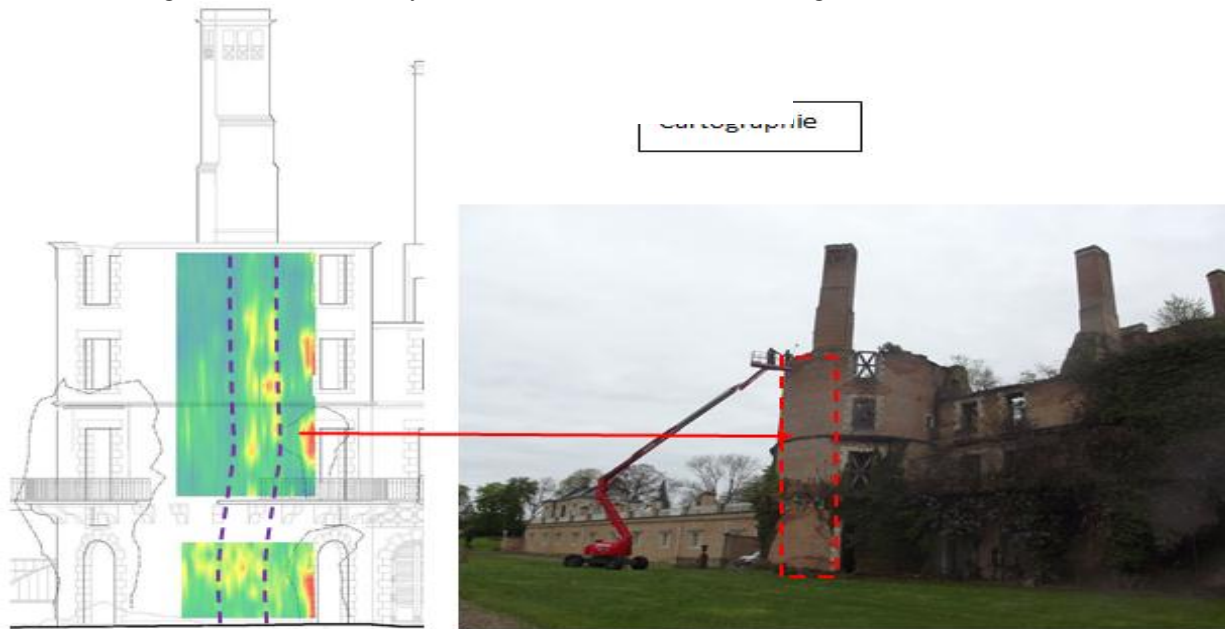
The mapping is carried out for a depth of investigation intersecting the internal duct of the chimney. Its trajectory is dashed. Some generalized anomalies (in yellow) on the lower map reflect a certain degree of heterogeneity of the masonry (presence of small voids and constitution in little cohesive mortar mortars). These results are correlated with the coring carried out at the bottom of the tower which has revealed a very friable nature of the mortar in the middle of the wall. The facade also shows signs of internal fractures visible from the outside, with the presence of decimetric roots, which walk in the middle of the bricks (Figure 11). In addition, the strong red anomalies at the edges of the openings are due to the presence of the stones paired: they do not reflect a defect in masonry.

Figure 11:-Cartography and photography of the tower
