# Assessment of Ecological Resources of Two Major Becks in Middlesbrough, North Yorkshire, United Kingdom

## Assessment of Ecological Resources of Two Major Becks in Middlesbrough, North Yorkshire, United Kingdom

### Abstract

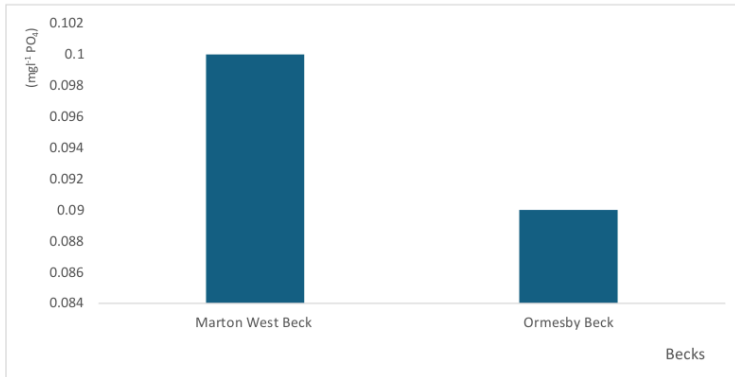
These nutrient levels are visualised in Figure 1, clearly illustrating the elevated phosphate and nitrate concentrations in Marton West Beck.

**Figure 1: Mean Phosphate Concentrations in Marton West Beck and Ormesby Beck.**

The physico-chemical water quality results revealed significant differences between Marton West Beck and Ormesby Beck (Table 1). Marton West Beck had significantly higher mean concentrations of both Phosphate ( $t(4) = 4.88$ ,  $p = 0.008$ ) and Nitrate ( $t(4) = 5.67$ ,  $p = 0.005$ ). The mean phosphate level in Marton West Beck (0.45 mg/L) was more than double that of Ormesby Beck (0.21 mg/L). Turbidity was also visibly higher in Marton West Beck, although the difference was not statistically significant with the small sample size. Dissolved oxygen and pH levels were broadly similar between the two becks and within ranges considered supportive of aquatic life.

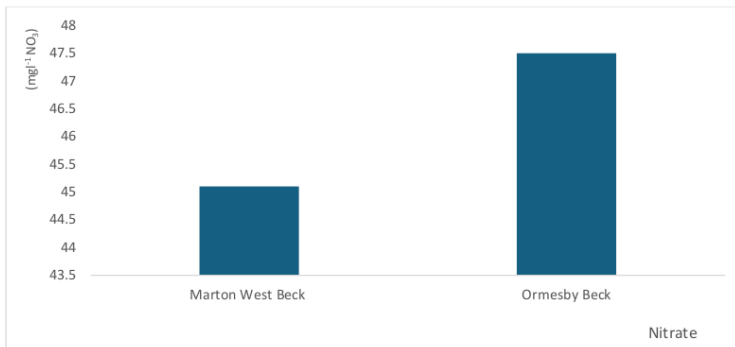
**Figure 2: Mean Nitrate Concentrations in Marton West Beck and Ormesby Beck.**

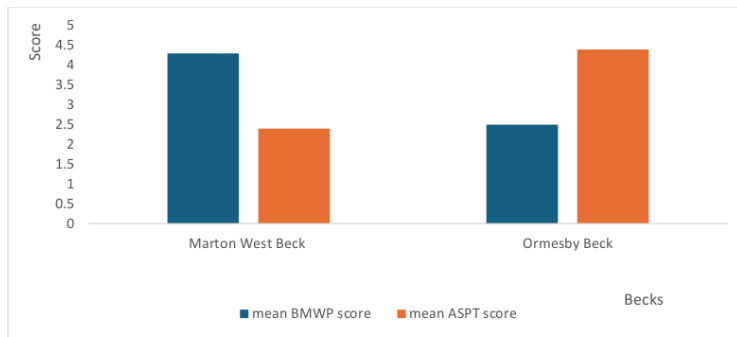
**Figure 3: Comparison of Mean Biological Indices for Marton West Beck and Ormesby Beck.**

The macroinvertebrate community data provided a clear biological confirmation of the trends observed in water and habitat quality (Table 3, Figure 2). A total of 18 scoring families were recorded across all sites in Ormesby Beck, compared to only 14 in Marton West Beck.

Site ID	Beck	No. of Taxa	BMWP Score	ASPT
MWB1	Marton West 10	72		4.5
MWB2	Marton West 8	55		3.9
MWB3	Marton West 7	68		3.8
<b>Mean Marton West</b>		<b>8.3</b>	<b>65</b>	<b>4.1</b>
OB1	Ormesby	15	110	5.8
OB2	Ormesby	12	95	5.3
OB3	Ormesby	11	89	4.5*
<b>Mean Ormesby</b>		<b>12.7</b>	<b>98</b>	<b>5.2</b>
