# MEDICAL DEVICE-RELATED ADVERSE EVENT: FEMORAL SHEATH FRACTURE DURING PTCA

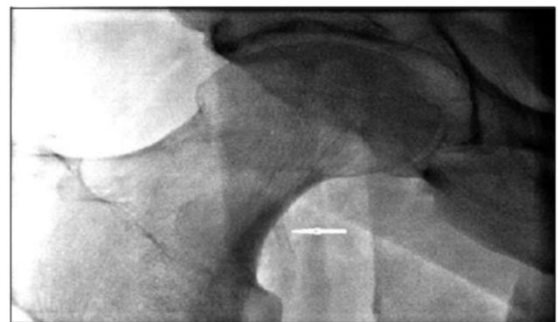
**Figure 1.** White arrow demonstrating the angiographic image of the trapped introducer sheath in the femoral artery.

Emergent imaging—via fluoroscopy and Doppler ultrasound—confirmed a retained

fragment lodged in the femoral artery. An attempt at percutaneous embolectomy was made but failed. An exploratory laparotomy was performed under vascular surgery, successfully retrieving the fragment. Postoperatively, the patient required ventilatory support and was extubated on the third day without neurological or vascular complications. The event was classified as a serious device-related adverse event and promptly reported to the Materiovigilance Programme of India for documentation and quality assurance purposes.

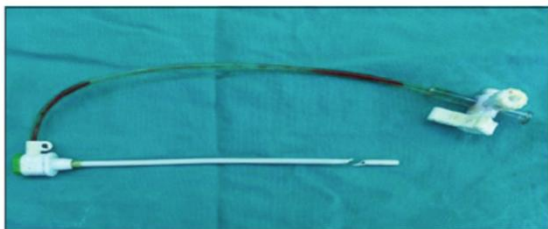
**Figure 2.** The main body and the fractured part of the introducer sheath after surgical retrieval.

Preventive measures revolve around meticulous device handling: inspecting the sheath before and after use for signs of crack or damage, avoiding forceful manipulation, and reducing dwell time when feasible. Furthermore, training interventional teams to recognize resistance during sheath maneuvers and to act swiftly is paramount. From a public health and regulatory perspective, materiovigilance reporting to MvPI plays a critical role. Documenting such rare but significant events enables pattern recognition, triggers action from manufacturers for redesign or recall, and informs institutional protocols to mitigate future risks [5]. In summary, while femoral sheath fracture is rare, its potentially life-threatening consequences call for heightened clinical vigilance, rapid management, and committed materiovigilance to ensure patient safety.
