INTERNATIONAL JOURNAL OF ADVANCED RESEARCH (IJAR)

ANALYSIS OF HUKURILA BEACH TOURISM LAND SUITABILITY HUKURILA VILLAGE SOUTH LEITIMUR SUB DISTRICT AMBON CITY

Tourism Suitability Index (IKW),
Hukurila Beach, Ambon City

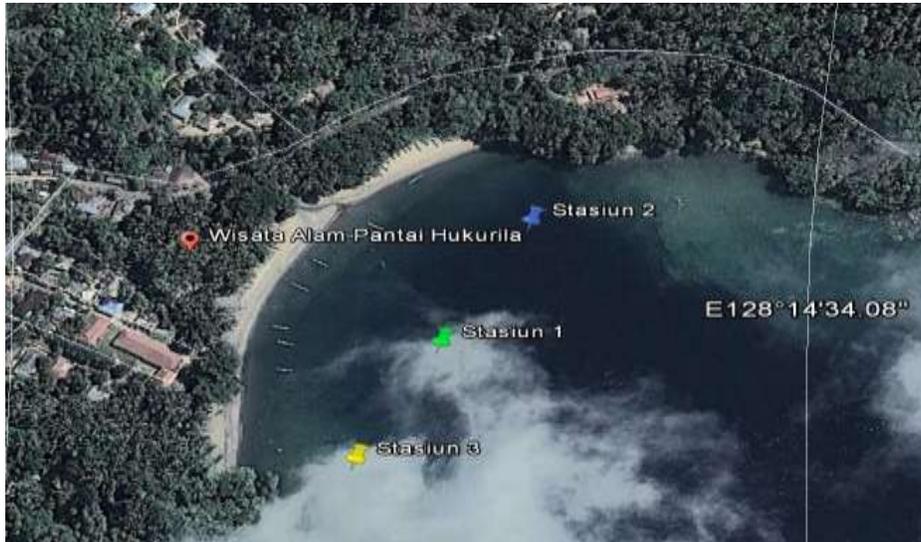
**Figure 2:-** Measurement Location of Waters Depth, station I, II, III.**Beach Type Conditions:**

The measurement analysis results of waters depth for the location of Hukurila Beach Natural Tourism Object, up to distance of 100 meters to the sea, the range at each station, namely for Hukurila Beach, at station I ranged from 5.15 meters, station II between 5.22 meters, and station III between 5.19 meters. This is supported by the statement (Hazeri2014) which provides depth value limit for the depth adjustment for the ecotourism of beach category to suitable between 3 and 6 meters. (Table 3).

Based on observations in the field, the condition of the waters in the location of the natural attractions of this beach, also have an impact on each form of visitor tourism activities. Swimming activities can be done by various age groups, including adolescents, and adults. However, considering the depth of the water above the range 5 meters, for children, swimming activities carried out need to be extra careful and need supervision (Figure 2)

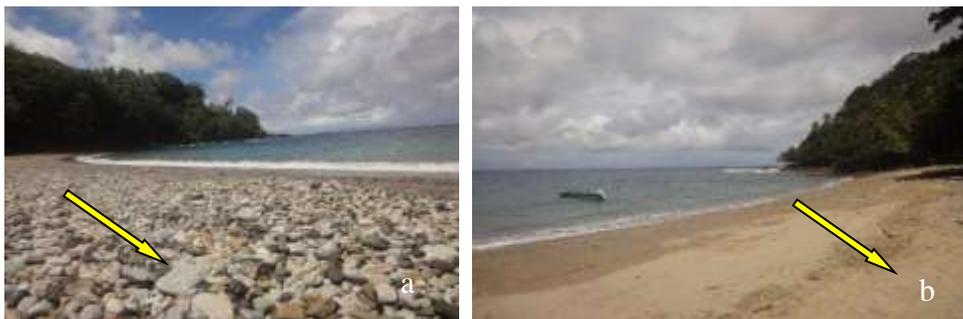
**Figure 3:-** (a). The direction of the arrow indicates Sandy Beach type
(b). The direction of the arrow indicates Gravely Beach type

Based on the material of its Natural Tourism Object, Hukurila Beach is beach composed of loose material. This type beach divided into Sandy Beach, which are beaches composed of sand deposits and gravel beaches, Gravely Beach, which are composed of loose gravels or rocks (Fig. 3).

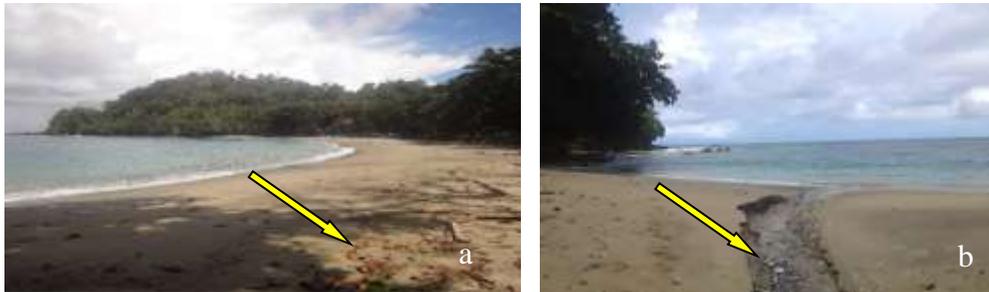
Figure 4:- (a). The direction of the arrow indicates the sand color on the beach natural tourism object due to sedimentation that occurred.
(b). The direction of the arrow indicates the river water flow which brings spoil and rock from the mainland.

Viewed from the perspective of the process of forming the Hukurila Beach, it is known that this beach occurs by the results of sedimentation processes. The beach has little white beach sand color brown. The color of the beach sand is the result of sedimentation process that occurs due to the process of transporting soil material, and gravel from the mountain land by water (Figure 4).

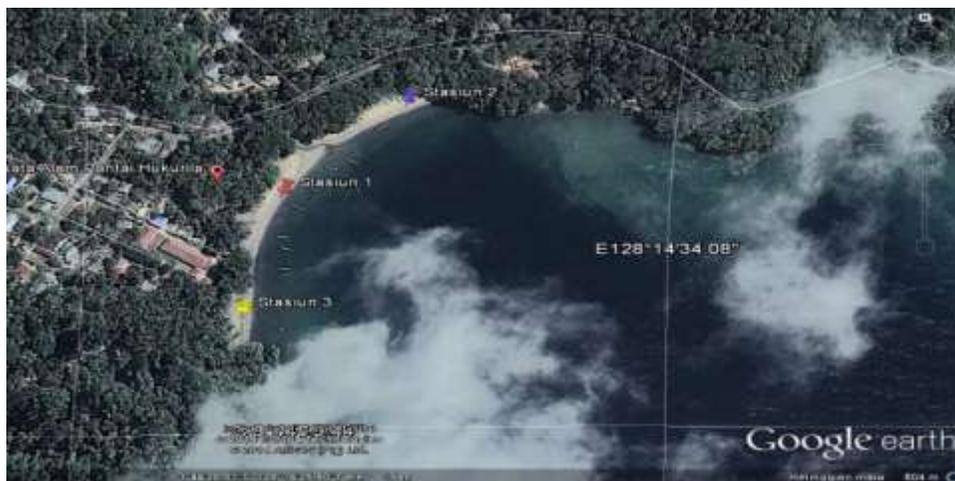
Figure 5:- Measurement Location of Beach Width, Station I, II, and III.

Measuring the width of the beach in Hukurila Beach Natural Tourism Object is done to find out how wide the beach area can be used for beach tourism activities. This beach width measurement is done by dividing the beach zone into three stations. The three predetermined stations are then measured (Figure. 5).

The measurement results on the Beach Natural Tourism Object of Hukurila, obtained beach width at station I is 23 meters, station 2, which is 20 meters, and station 3 is 18 meters (Table. 4).

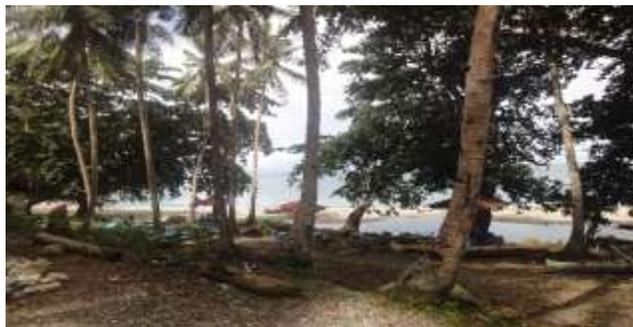
Figure 6:- Beach Land Cover.

Based on observations made on the cover of coastal land in HukurilaBeach Natural Tourism Object, it was found that this beach natural tourism object, beach cover is dominated by vegetation composition consisting of coconut trees (*CocosNucifera*), ketapang trees (*TerminaliaKatappa*) and open land. The cover of coastal land which is dominated by the growth of coconut trees, ketapang trees and open land, provides a shady and cool atmosphere to the visitors doing recreational activities. Thus according to the suitability matrix of coastal land cover conditions, these natural tourism objects can be classified into egoreic words accordingly (Fig. 6).

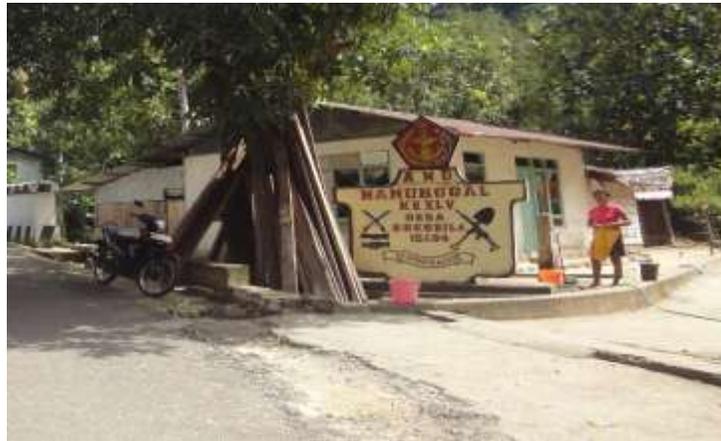
Figure 7:- Freshwater sources.

Tourism activities will not run smoothly if it is not supported by the availability of fresh water. Based on observations made on natural objects of Hukurila Beach, it is found that in this tourism object it has distance of availability of fresh water to a resident's house which can be said to be quite close, which is around 500 meters from a water source. As according to Yulianda (2007) in the land suitability matrix of the coastal tourism category that a beach tourism can be said to be very suitable if it has a distance of fresh water availability <0.5 km. (Figure 7).
