### RESEARCH ARTICLE

#### COMPARISON OF SHEAR BOND STRENGTH OF THREE COMPOSITE RESIN REPAIR MATERIAL WITH CERAMIC AND COBALT CHROMIUM SURFACES AFTER VARIOUS SURFACE TREATMENTS - AN INVITRO STUDY

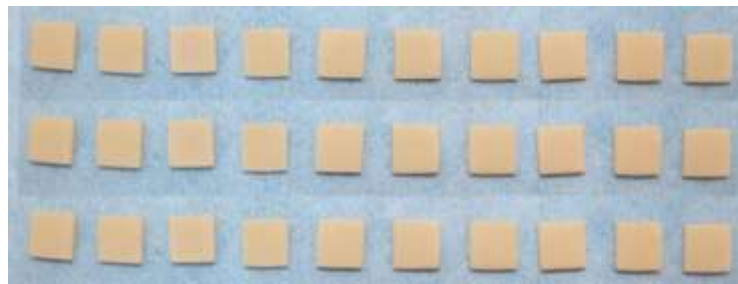
Fig. 2:- Thirty metal ceramic samples.

In this study 30 metal ceramic samples (Fig 2) and 30 Cobalt chromium metal samples (Fig 3) were used . Wax patterns for the samples were prepared with casting wax of standardized dimensions. Spruing and investing done according to manufacturer's recommendations. Ringless casting technique was followed in this study. The samples were fabricated in vacuum pressure induction casting machine (Argon caster AE, Shofu Inc, Japan) .The alloy was Co-Cr dental alloy (Colado CC, Ivoclar Vivadent).The castings were then divested, and the sprues were separated. A sandblaster with 50  $\mu\text{m}$  aluminium oxide ( $\text{Al}_2\text{O}_3$ ) was used to remove any remaining investment.

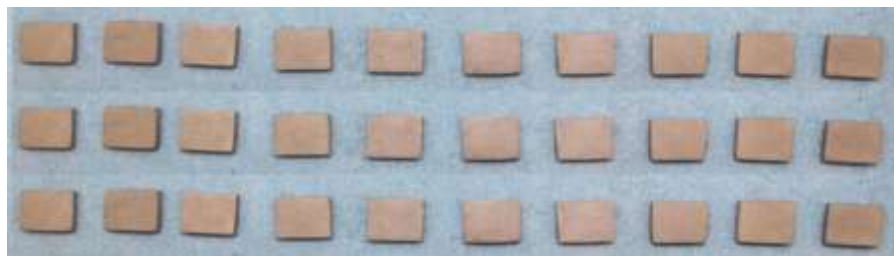
Fig 3:- Cobalt chromium metal samples.

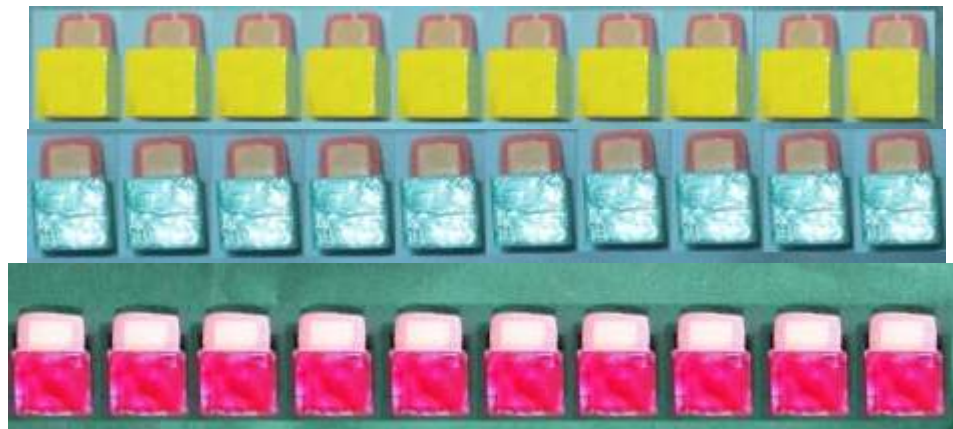
Fig.4:- Metal ceramic group- CI,CII,CIII.

The 30 metal ceramic samples were further grouped into -CI, CII and CIII (Fig.4 ) and 30 Cobalt chromium alloy samples into -MI, MII, MIII with each sub group containing 10 samples (Fig.5) . All specimens were grounded using a fine-grit diamond rotary cutting instrument in a high-speed hand piece with water irrigation for 10 seconds. The composite resin material was added 6x4mm using a Teflon coated metal holder (Fig6).

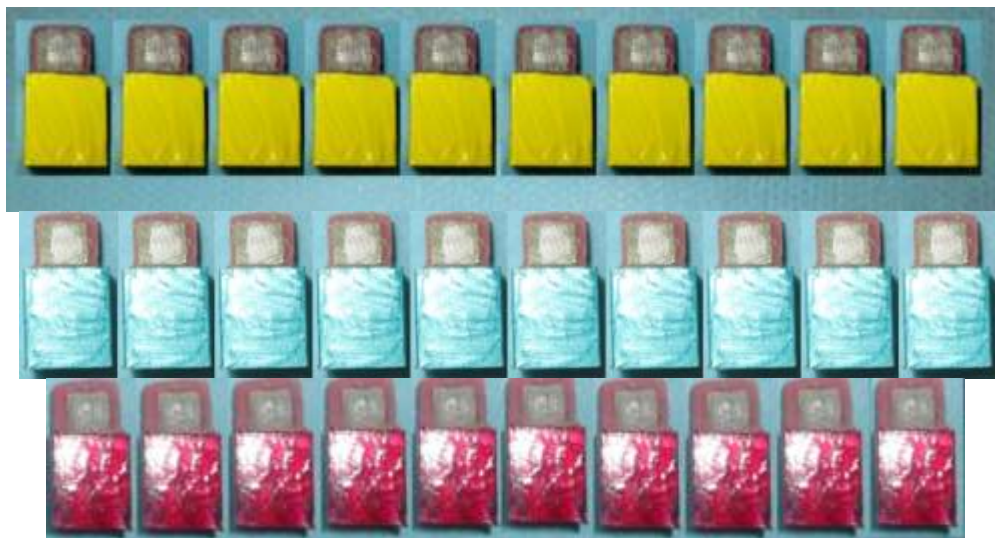
**Fig. 5:-** Cobalt chromium metal group- MI, MII, MIII.

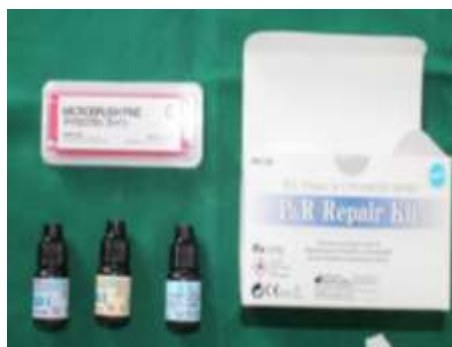
**Fig 7:-** P and R Repair kit.

| S Group<br>( Fig 7) | CII | <ul style="list-style-type: none"> <li>• CRB1 followed by CRB2 added and left for 10 secs</li> <li>• Light curing for 10 secs</li> <li>• Repair material added - cured</li> </ul> |
| | MII | <ul style="list-style-type: none"> <li>• ML Primer added</li> <li>• Left for 10 secs</li> <li>• Repair material added- cured</li> </ul> |

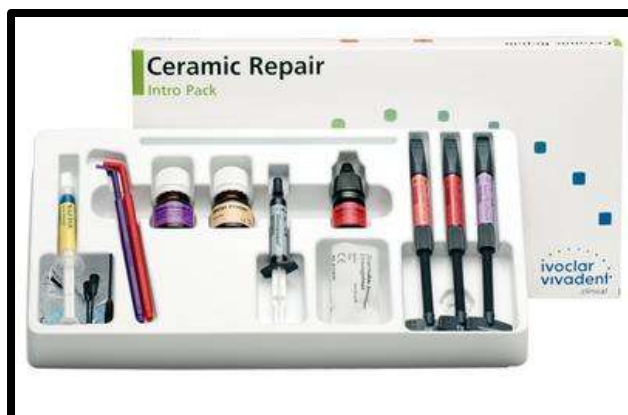
**Fig 8:-** Ivoclar ceramic repair kit and component.

| I Group<br>(Fig 8) | CIII | <ul style="list-style-type: none"> <li>• Sample Surface sample modified with intraoral sandblaster-50<math>\mu</math> kept at a distance of 5-19mm distance from needle tip to the blasting surface with a compression air pressure at 60~ 80 lbf/pol2 (4-5,5Kgf/cm2 Al2O3-15 secs(Fig 9).</li> <li>• Etched with H3PO4 for 30 secs</li> <li>• Silanating agent-Monobond S -60 secs</li> <li>• Heliobond applied-10 secs</li> <li>• Repair material added - cured</li> </ul> |
| | MIII | <ul style="list-style-type: none"> <li>• (Sample surface modification and etching with H3PO4as above)</li> <li>• Metal zirconia primer applied- waited for 3 mts</li> <li>• Heliobond applied- 10 secs</li> <li>• Repair material added- cured</li> </ul> |

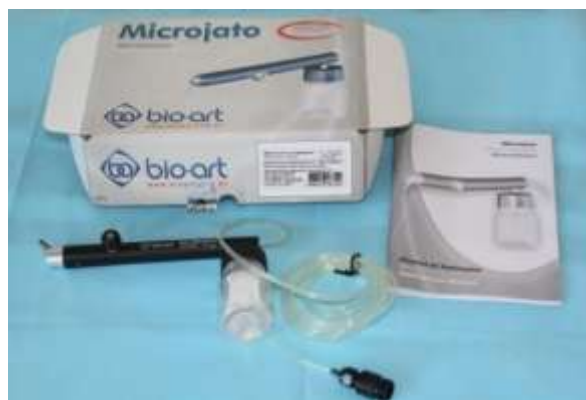
**Fig 9:-** Intraoral sandblaster.
