INTERNATIONAL JOURNAL OF ADVANCED RESEARCH (IJAR)

RESEARCH ARTICLE

COMPARATIVE EVALUATION OF SEALING ABILITY OF FOUR DIFFERENT ROOT REPAIR MATERIALS USED FOR FURCATION PERFORATION REPAIR: AN INVITRO STUDY

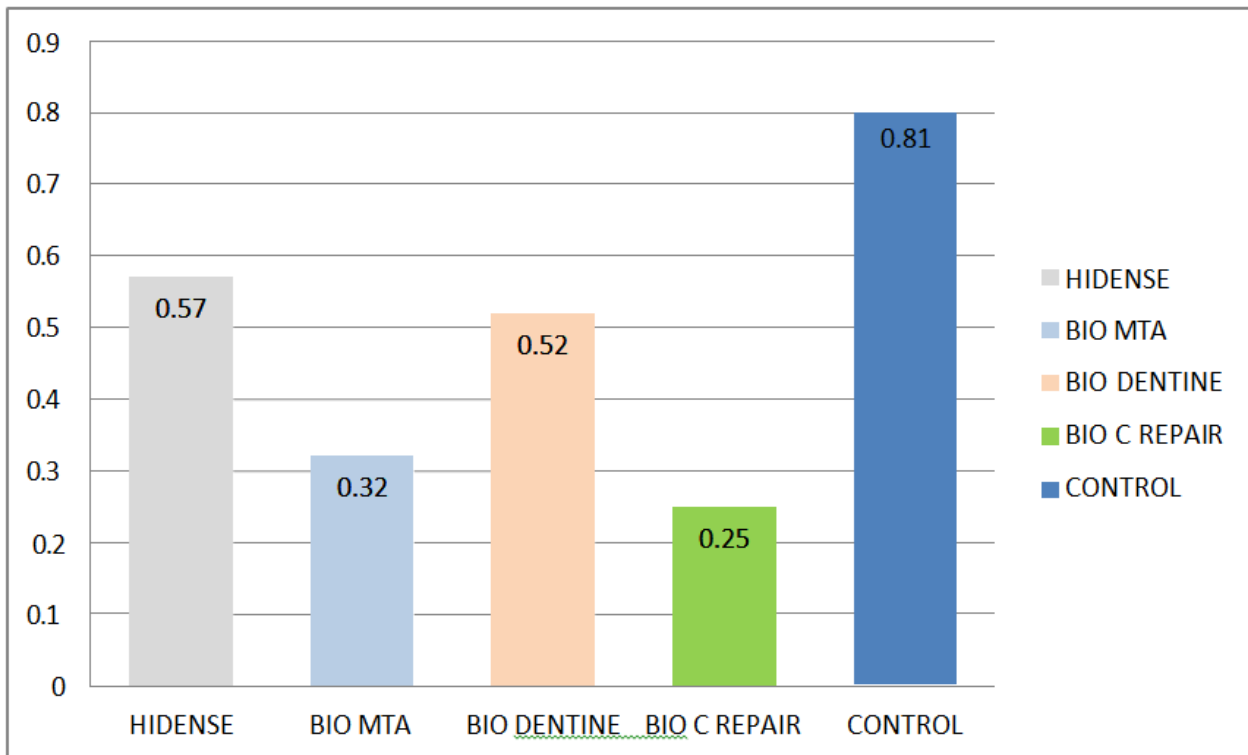
GRAPH 1: Mean Protein Leakage Assessment of Different Root Repair Materials for Furcation Perforation Repair

Table 1 and graph 1 outline the mean protein leakage assessment of different root repair materials for furcation perforation repair. Highest mean protein leakage was seen for control group 0.81 ± 0.03 . Followed by the control group, HIDENSE exhibited the next highest values during the assessment i.e; 0.57 ± 0.56 . the least score was elucidated by Bio C repair , which is 0.25 ± 0.01 .
