### RESEARCH ARTICLE

## CONSERVATIVE MANAGEMENT OF A GROSSLY DECAYED MANDIBULAR MOLAR WITH RADIX ENTOMOLARIS: ENDODONTIC THERAPY AND POST-ENDODONTIC REHABILITATION

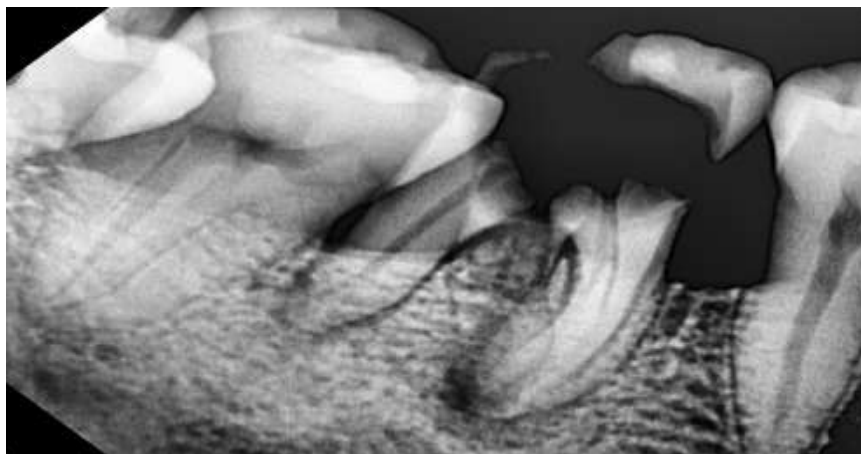
Figure 1 – Preoperative Radiograph

A 27-year-old female patient reported to KD Dental College and Hospital, Mathura with the chief complaint of a grossly decayed tooth in the lower right posterior region. The patient did not report any pain or discomfort associated with the tooth. Clinical examination revealed extensive coronal destruction with mild gingival recession. The tooth was non-tender on percussion and palpation, and no mobility was observed, suggesting a chronic condition. Radiographic examination revealed significant bone loss and furcation involvement. An additional root was identified distolingually, suggestive of radix entomolaris.(Figure-1)Based on the clinical and radiographic findings, the tooth was diagnosed as Pulpal necrosis with asymptomatic apical periodontitis in a grossly decayed mandibular molar with radix entomolaris and associated periodontal bone loss.

Considering these findings, the prognosis of the tooth was considered questionable. Extraction followed by prosthetic rehabilitation was initially advised; however, the patient expressed a strong desire to retain the natural tooth. Considering the patient's preference, a conservative treatment plan involving root canal therapy followed by post-endodontic restoration was formulated. Endodontic treatment was initiated under rubber dam isolation. Access cavity preparation was performed, and careful exploration of the pulp chamber was carried out to locate all canal orifices, including the additional canal associated with radix entomolaris. Working length was determined using an apex locator and confirmed radiographically (Figure 2). Biomechanical preparation was carried out using rotary instrumentation up to size 24/04. Copious irrigation was performed using sodium hypochlorite, saline, and EDTA, with activation to enhance disinfection. Calcium hydroxide was placed as an intracanal medicament, and the patient was recalled after one week.

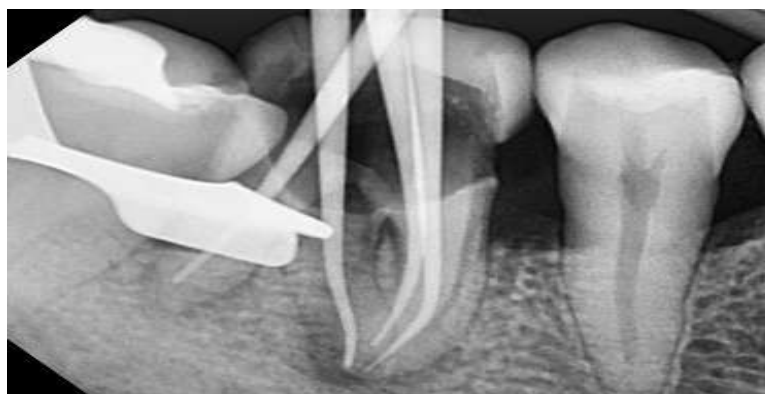
**Figure 3 – Masterapical Radiograph**

At the subsequent visit, the canals were asymptomatic and dry. The master apical gutta-percha cone was selected and its fit was verified radiographically (Figure 3).

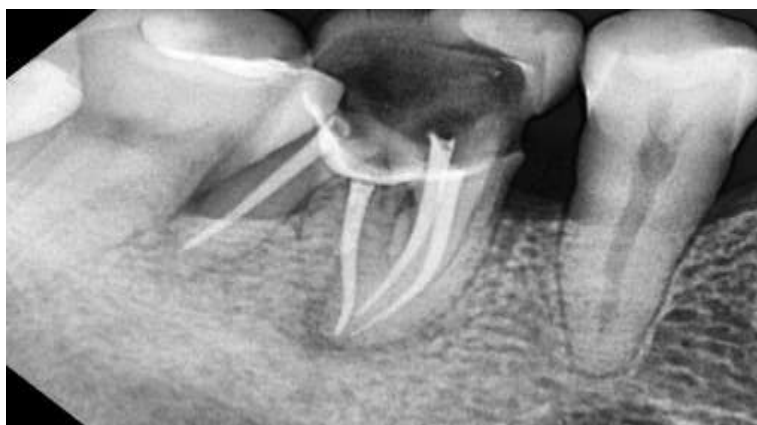
Obturation was completed using gutta-percha in conjunction with a bioceramic sealer to achieve a three-dimensional seal (Figure 4).

**Figure 4 -Immediate Postoperative Radiograph Demonstrating Three-Dimensional Obturation Of All Canals Using Gutta-Percha And Bioceramic Sealer.**

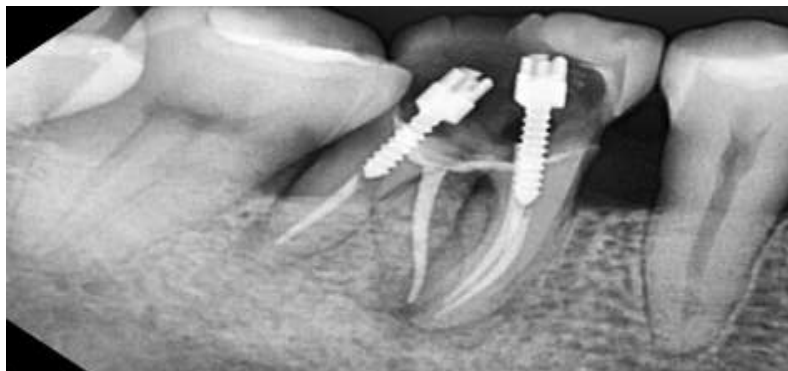
After a short interval, post space preparation was performed in the selected canal, and a prefabricated metal post was placed. The post position was verified radiographically and cemented using glass ionomer cement (Figure 5).

**Figure 5- Radiographic Verification Of Prefabricated Metal Post Placement Following Post Space Preparation In The Selected Canal.**

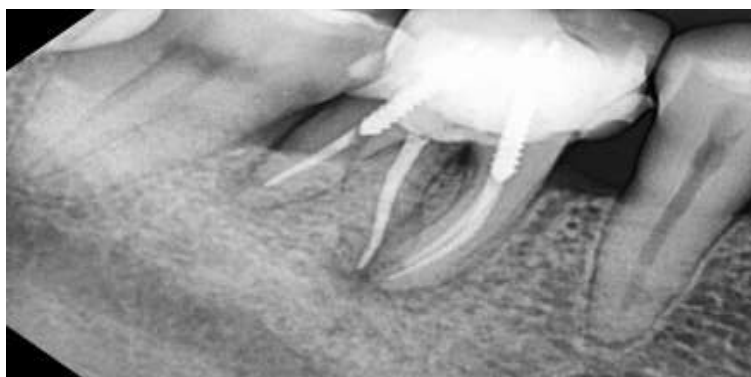
Core build-up was completed to restore the lost tooth structure. (Figure 6 )

**Figure 6 -Postoperative Radiograph Showing The Core Build-Up Performed Following Cementation Of The Prefabricated Metal Post.**

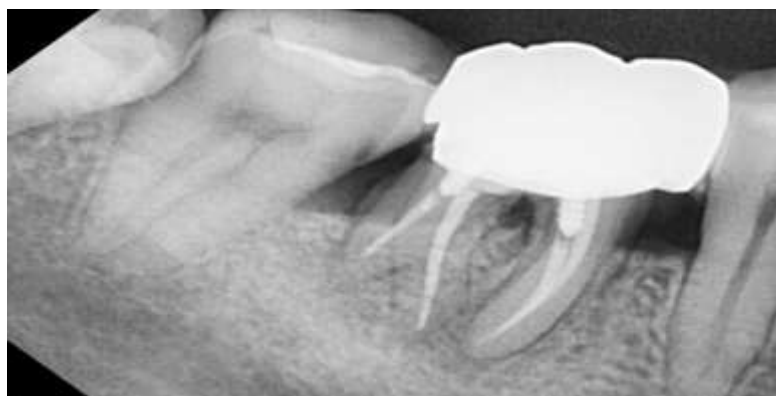
Following adequate core formation, tooth preparation for full-coverage restoration was carried out. A crown was fabricated and subsequently cemented, thereby restoring the function and esthetics of the tooth. (Figure 7)

**Figure 7 -Final Postoperative Radiograph Demonstrating The Definitive Full-Coverage Crown Restoration And Rehabilitation Of The Tooth.**
