### RESEARCH ARTICLE

#### RETRIEVAL OF FRACTURED NI-TI ROTARY INSTRUMENT USING ULTRASONICS AND INSTRUMENT RETRIEVAL SYSTEM UNDER DENTAL OPERATING MICROSCOPE

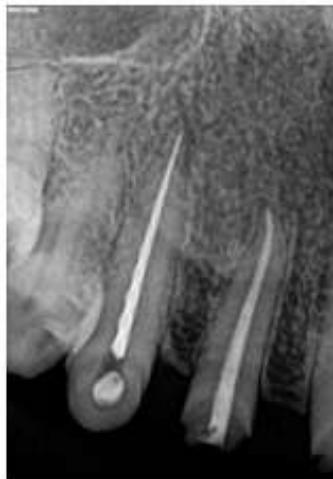
Figure 1: Pre-operative radiograph

on percussion and palpation. Periodontal probing depths were normal. Tooth was nonvital. Intraoral periapical radiograph (IOPA) revealed separated instrument fragment, extending approximately from 2 mm below the canal orifice, to the apex around 15 mm. [Fig. 1]. The case was diagnosed as a previously initiated root canal treatment with asymptomatic apical periodontitis in relation to 13.

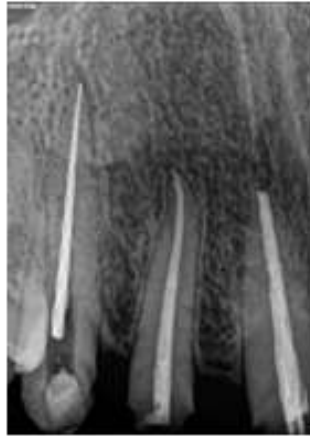
Figure 3: After ultrasonic troughing

Ultrasonic vibrations (direct and indirect) failed to deliver the instrument out of the canal as it was tightly engaged to the adjacent dentin near the apex. Hence, additional troughing was performed on the buccal aspect of the canal to free the instrument from dentin. This caused the partial loosening of the fractured instrument from the dentin [Fig.3].

After the administration of local anaesthesia (2% lignocaine hydrochloride with adrenaline 1:80,000) under rubber dam isolation, the access cavity was modified and the lingual shoulder was removed using Gates Glidden (GG) drill- 3,- 2,- 1(Dentsply,Ballaigues,Switzerland) to ensure a straight line access to the coronal end of the fragment. When viewed under the dental operating microscope (Labomed, Operating microscope) at  $\times 3.5$  magnification, the coronal part of the separated instrument was visible and the fragment was oriented toward the buccal aspect of the canal and was threaded into the dentin. The dentin surrounding the fractured fragment was troughed using ultrasonically activated ET25 tip mounted on handpiece (ACTEON, Satelec) at a power setting 3 under coolant [Fig.2]. Troughing was initially performed on the palatal aspect to free the coronal end of the fragment.

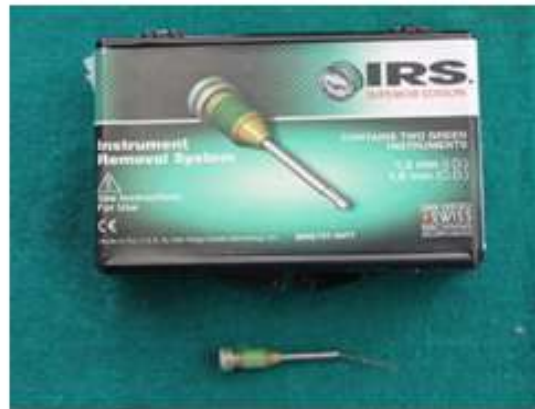
Figure 4: IRS kit

IRS system was then employed for retrieval. Microtube of the IRS system was inserted into the canal with the long part of its beveled end oriented to the wall to “scoop up” the head of the separated instrument and guide it into the microtube. Success in guiding the head of the separated instrument into the microtube was achieved after few attempts. Same color-coded screw wedge was then inserted and slid internally through the microtube’s length until it contacted the separated instrument. The separated instrument was engaged by gently turning the screw wedge handle counterclockwise. A few degrees of rotation served to tighten, wedge and often displace the head of the separated instrument through the microtube window. The separated instrument was removed by rotating the microtube and screw wedge assembly out of the canal in counterclockwise . The microtube and the screw wedge were taken out of the canal along with the separated instrument [Fig 4 and 5].

The IRS system provides a procedural breakthrough for the removal of intracanal obstructions such as silver points, carrier-based obturators or broken file segments. The IRS system is indicated when ultrasonic efforts prove to be unsuccessful to remove broken instruments that are lodged in the straightaway portions of the root or partially around the canal curvature. One of the most important factors to be considered prior to instrument retrieval by this system is to obtain a straight line access to the coronal end of the separated instrument by the use of modified gates glidden drills, #1 and #2 sectioned at their maximum cross-sectional to obtain a flat end. The objective here is to create a straight line access to the coronal aspect of the separated fragment. However, this leads to removal of a considerable amount of radicular dentin and can cause iatrogenic damage like perforation. Close inspection of pre-operative radiographs and knowledge of root anatomy is imperative before attempting the removal procedure in any tooth to ascertain the relative amount of surrounding dentin and the risk of perforation. File removal generally results in ledge formation and therefore a possible stress concentration point. When the file is located in the middle or apical third of the root, removal procedure significantly reduces the root strength.<sup>(3,7)</sup>

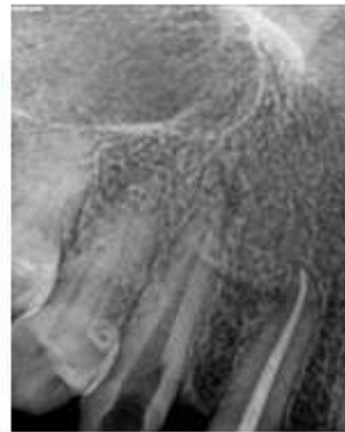
Figure 6: After removal of the separated file

Radiographs were taken to make sure that finally the canal was cleared of obstruction [Fig 6]. When viewed under the dental operating microscope (Labomed, Operating microscope) at  $\times 3.5$  magnification, the canal was cleared from the separated file [Fig 7]. The fractured fragment was measured and was approx. 15 mm [Fig 8]. Working length radiograph was then taken and the canals were prepared and irrigated with 2.5% sodium hypochlorite during instrumentation. The final irrigation was performed using 17% EDTA and 2.5% sodium hypochlorite. The canal was dried with absorbent paper points and obturated with cold lateral compaction technique. The access cavity was restored with resin composite Filtek Z250 (3M Dental Products, St Paul, MN, USA) [Fig 9,10]. The patient was asymptomatic during the 4- week follow- up period.
