FAILURE INVESTIGATION FOR INPUT SHAFT OF AUXILIARY HOIST GEAR BOX.

Rahul S Korde and Amol N Patil.

This review paper gives the insights of various analysis & tests carried out to find shaft failure type & its causes. Failed shaft is used in auxiliary hoist gear box for torque transmission. Shaft failed with fewer cycles of operations in very early stage of life span. The various literatures has been systematically studied, compared and reviewed to get a proper shaft failure analysis and their causes. Every analysis method has its advantages and disadvantages and used by specific industrial areas. Shaft failure causes the unnecessary shutdowns and leads to larger production losses. The objective of this paper is to study various shafts failure analysis techniques and select the best method to find out the root cause for failure of shaft used in crane hoist.

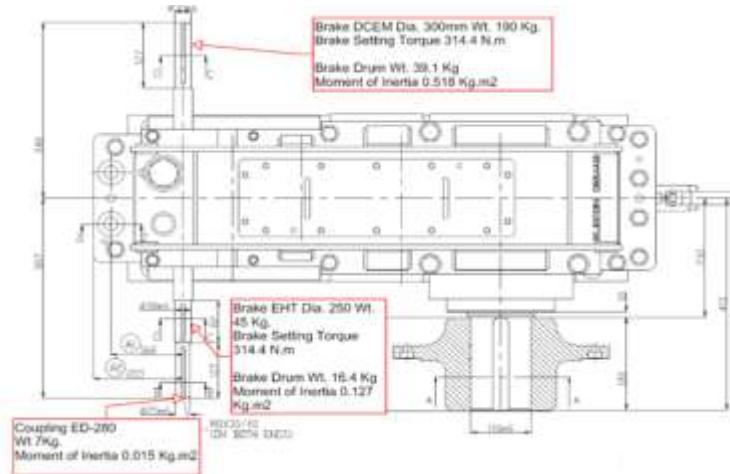
The manufacturing route of shaft is as mentioned: forging – turning – hobbing – heat treatment – teeth grinding – OD grinding. The heat treatment is carried out as per shaft drawing. The gear box is driven by motor and there is thruster brake between gear box and motor. Failure took place between brake and motor. Geared coupling is used between motor and brake.
