### ORIGINAL RESEARCH

## COMPARATIVE EVALUATION OF FRACTURE RESISTANCE OF ENDODONTICALLY TREATED MANDIBULAR MOLARS RESTORED WITH DIRECT CONVENTIONAL COMPOSITE VERSUS COMPOSITE RESTORATION REINFORCED WITH HORIZONTAL FIBERGLASS POSTS: AN IN - VITRO STUDY

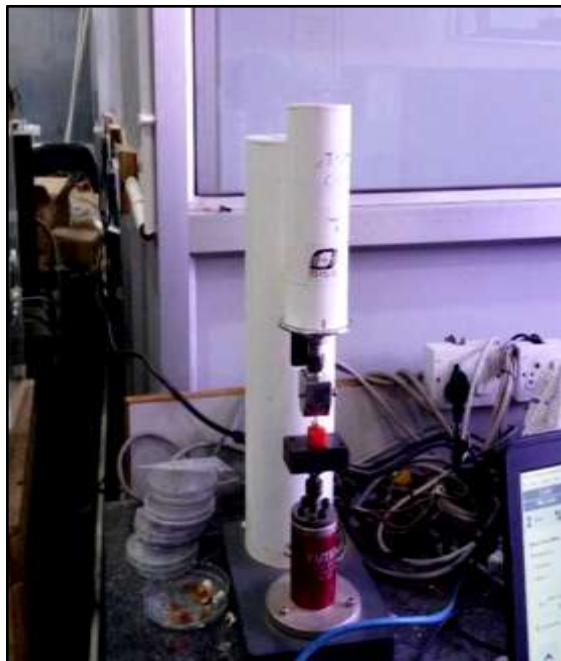
Figure 2: Specimen mounted in Universal Testing Machine for fracture resistance testing.

**Fracture Testing:** All specimens were embedded in acrylic blocks below the cemento-enamel junction (CEJ). They were stored in saline at 37°C for 24 hours. A universal testing machine applied compressive load at a crosshead speed of 1 mm/min until fracture occurred [Figure 2]. Maximum load to fracture (N) was recorded.
