## **Two Case Studies: Real-life fatal burn case including smoke inhalation and fatal high-voltage electrical burn**

### **Case 1: Man redecorates kitchen and dies in fire.**

### **Case 2: Real-life fatal high-voltage electrical burn**

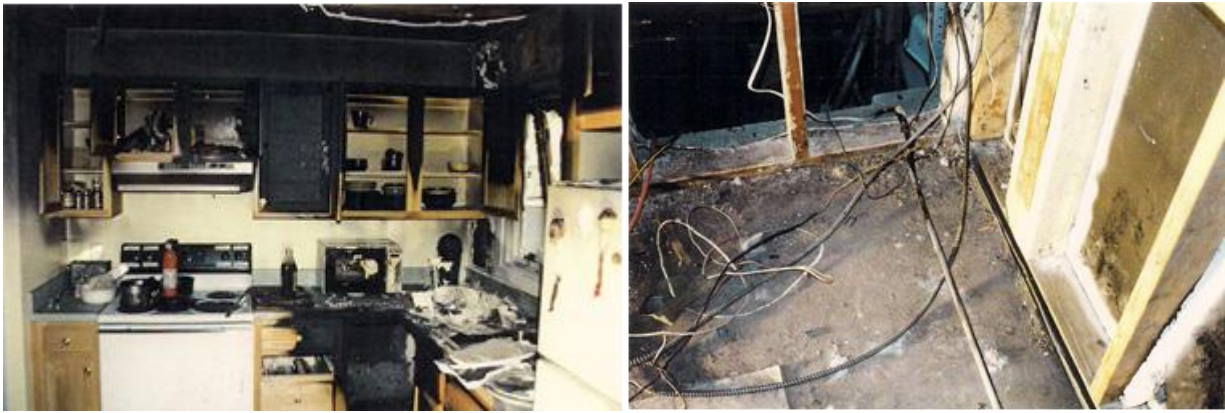
The fire damage was small. It was caused by the refrigerator wire under the cabinets, directly below the microwave oven, which sat in the corner. See Fig. 1(a). However, the owner died of smoke inhalation.

Fig. 1: (a) The kitchen after the fire. Fire extinguisher on top of stove is un-used. (b) Fridge wire (long straight wire) was found as the point of ignition for the kitchen fire.

*Investigation and Discussion:* The fire itself was small. One row of wall cabinets was damaged. A microwave oven underneath the cabinets was lost. The refrigerator was slightly blackened but functional, except for the cord leading to it. See Figure 1(a). The investigation found that a #12 gauge wire was run under the cabinets to the refrigerator. See Fig. 1(b). Typically, the fridge drew 10 amps. The wire could safely carry 20 amps. Yet, the cord was the site of the ignition of the fire. How can the cord have gotten hot enough to ignite a fire when the current was only half the rated maximum? Or to put this another way, how could the cord heat up enough to cause the fire when the heat generated was only  $\frac{1}{4}$  of the rated safe maximum?

The cord started the fire due to the phenomenon of pyrolysis. The term pyrolysis has several definitions, especially in the subject of chemistry. For our purposes, it means a “slow burn”. We are used to thinking of the flashpoint of burning. For paper and most wood and wood products, ignition is at 451 degrees Fahrenheit. Temperatures under this value are considered too cool to burn or too cool to ignite a burn. In pyrolysis, a high temperature (but lower than the ignition temperature) heats up the material, and in the process it makes it more easily combustible by breaking down its structure. The process can go on for hours or weeks or even months. At some point the wood will ignite, and the temperature of ignition is lower than the normal value (451 F). When the wire was run from the far wall to the refrigerator, the kitchen cabinets were placed directly on top of them. This is sloppy carpentry on the part of the contractor, since it required extra steps in leveling the cabinets. The cabinets essentially flattened the copper wire. But apart from the sloppy carpentry, there was the additional problem of heat buildup. The wire made intimate contact with the base of the wood cabinet. Over time, this wood came closer to the ignition point. After 3 months the wood ignited into a fire.

Protocols involve the use of the NEC (National Electric Code) to define safe procedures for the implementation of even the simplest electric circuit. It should be pointed out that the NEC has a rule regarding the contact of cabinets and wire run in this fashion [2, 3]. The contractor must “notch” the bottom base of the wood cabinets. The wire can then run under the cabinets with a layer of free air surrounding it. Any heat built up can then be easily dispersed, even in areas where air flow is stagnant.

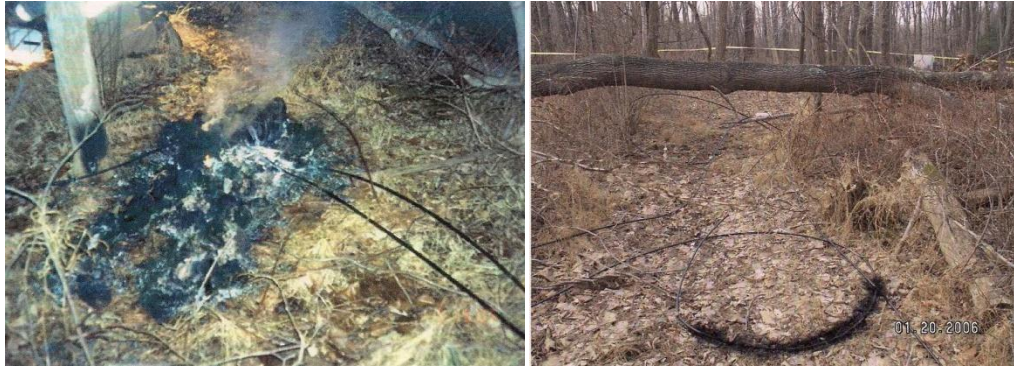
The police/fire/first-aid crews find the homeowner or what is left of him. He is on his property in the woods, one hundred yards from the house. He is burned so badly that most of his bones are showing. Positive identification can only be made later from dental records. There is a 5,000 volt power line broken but lying on top of the man. See Fig. 2(a). Before the rescue crew can approach, they must tell the power company to kill power to the line. There is a series of poles (aka telephone poles or power poles) from the main road. They are on the owner's estate leading through the woods to the guest house and from there to the main house.

Figure 2: (a) Body of the man burned by 5000 Volt power line falling on him. (b) Fallen tree with broken power lines and stretched cable lines.

There was one theory that seemed to make the most sense, given the bizarre circumstances and the lack of hard evidence. A tree breaks and falls on the power line. The power line is accompanied by several other wires, including a phone wire and another wire from the cable TV company. A tree is weakened by disease and age and falls. It lands on the power bundle. But the wires do not break. They support the tree. There is a break in the junction box from the tension of the tree on the wires. The house loses power. The homeowner calls the electrician. While waiting, the homeowner sees smoke in the woods. He goes to investigate. Even though the tree is supported by the wires, the power wire is broken at the junction box and at that point there would be sparking and smoke as the live line made erratic connections to ground. The owner gets close to get a better look. At that point the power wire snaps. In the fashion of a whip it springs out and lands on the homeowner. Note: the two low power cables (phone/cable TV) did not snap. They just stretched more and more as the full weight of the tree came to rest on them. They were still connected from pole to pole (though bowed in the center) when the rescue team arrived. See Fig.2(b). The homeowner may have been electrocuted as well as burned. There is no way to tell. The outer body was so badly burned, that death could have been by electrocution or burning or both. Fig. 2b shows the fallen tree, the snapped power wire, and the overly stretched TV/phone wires.

Snow and winds may cause trees to sway into power lines, break off limbs or fall into power lines. Arcing usually accompanies such faults. Clearance requirements around electrical poles and towers are necessary to prevent such fatal accidents. The removal or trimming of trees, or portions of trees, that are dead, decaying, rotten, or diseased and which may fall into or onto the line and trees leaning toward the line is important to prevent possible danger.
